**US Army Corps
of Engineers®**
Engineer Research and
Development Center

Evaluation of Typar® Geocell Flood Fighting Barrier

Donald L. Ward

November 2010

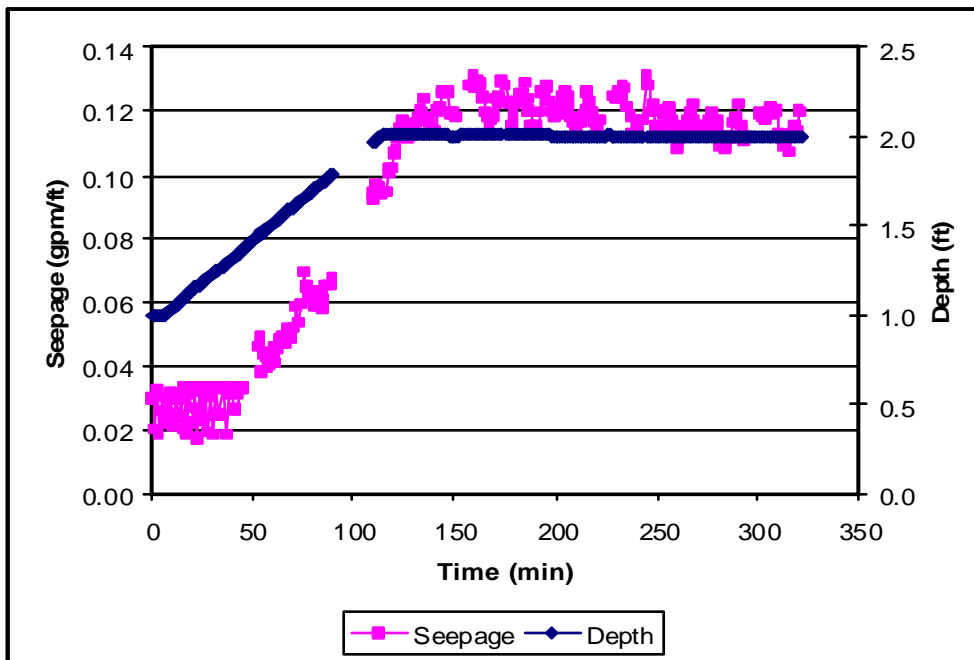
A leak was discovered in one wall of the test area. As the water level in the basin rose to the 2 ft depth, the leak became more pronounced. Near the end of the 22 hr test period at a 2 ft depth, the leakage through the wall was measured at 0.061 gpm, which would add 0.0008 gpm/ft to the barrier seepage rate.

Figure 29. Seepage rate as basin water level raised to 2 ft. Measurements started at 1000 hrs.

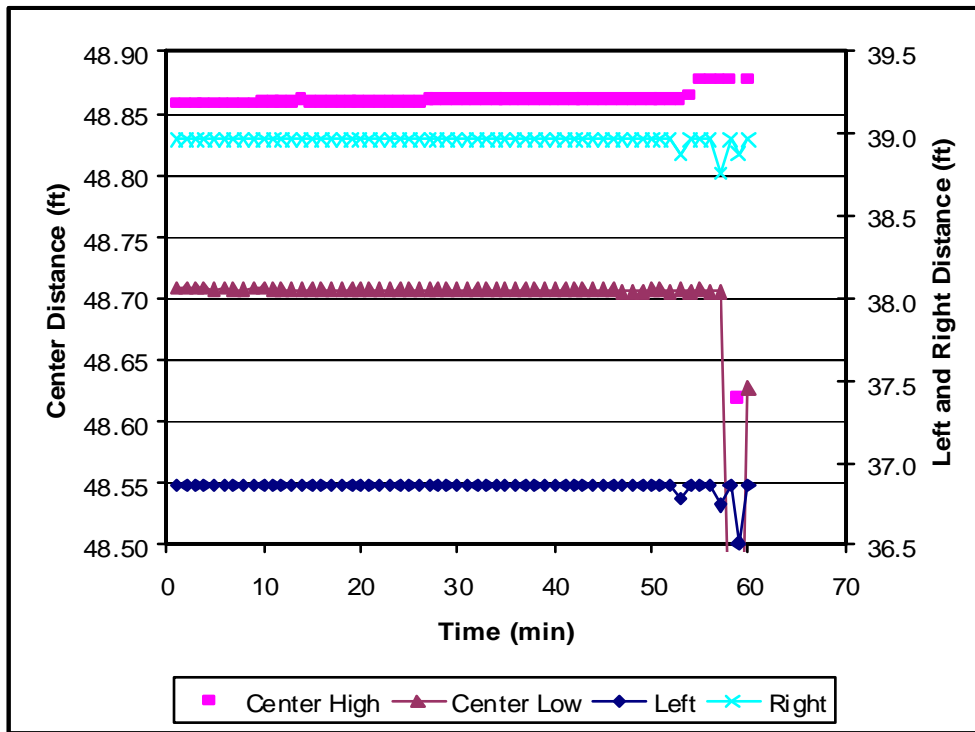
Laser measurements of the structure show a sudden change in the center high distance at about 50 min. into the test, indicating the target moved away from the laser by about 0.06 ft (Figure 42). It is not likely that the structure would move away from the lasers when the water pressure is pushing the structure towards the lasers. The laser target is taped to the plastic sheeting wrapped around the structure. It is probable that the plastic sheeting shifted and caused the target to move the 0.06 ft. However, this is just conjecture.

Figure 42. Movement of structure sections during tests at high water with small waves. Measurements started at 1444.

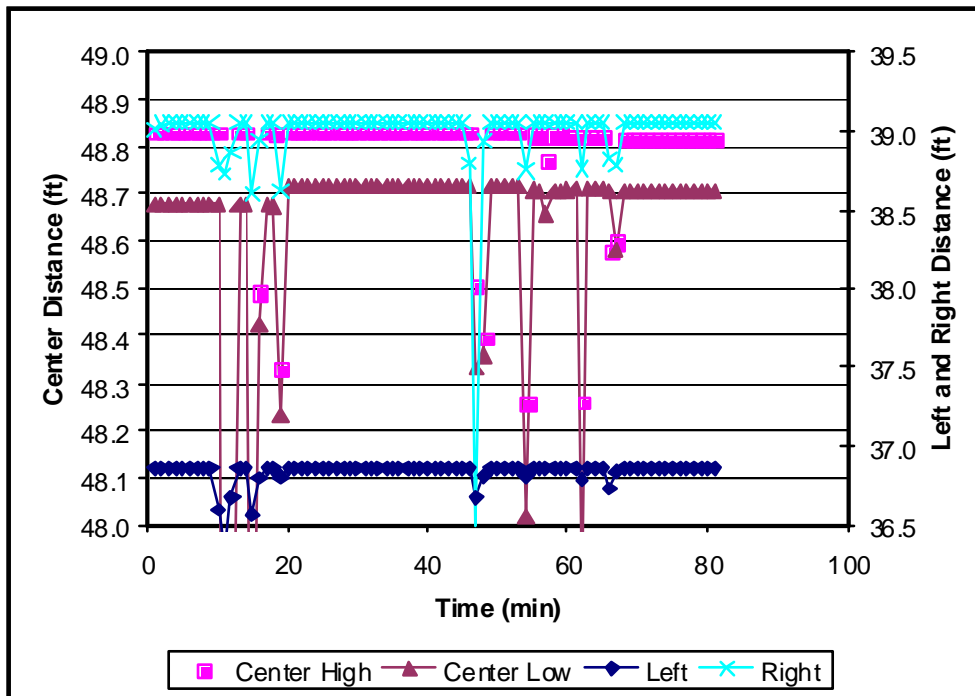
Movement of the structure is shown in Figure 56. Lines in the figure that drop below the graph were caused by people walking between the lasers and the targets.

Figure 56. Structure movement during debris impact test.

Closer examination of the raw data shows that center high target moved inward by 0.003 m (0.12 in.) and the center low laser target moved inward by 0.002 m (0.08 in.) at minute 54 in the recording, and that the structure then stayed in the new position. It is assumed that this movement was caused by impact with the large log. There was no evidence of any movement caused by the small log.

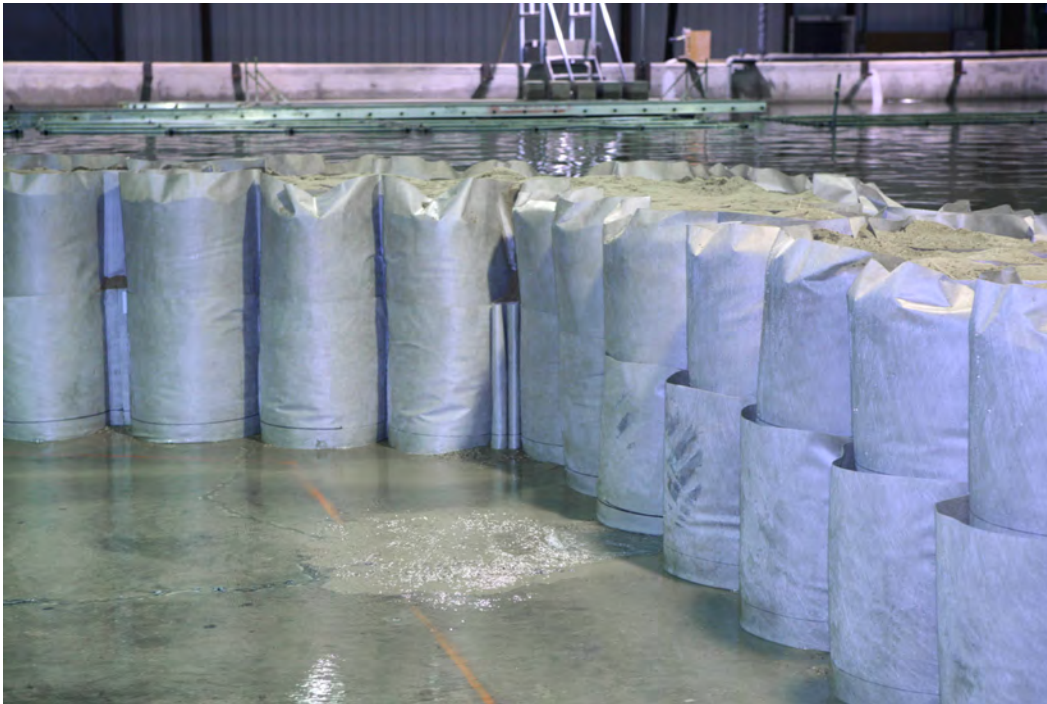
Figure 57. Seepage flow through joint in barrier near the angled Geocell unit.

The joint that included the bend in the Geocells was formed by filling the first few cells in a straight line with the previous Geocell, then turning the framework and the remainder of the Geocell to form the bend (Figure 13 and Figure 14). When the frame was rotated, the Geocell was only lightly held in place because only the first cells had been filled. It is likely that the seal with the previous Geocell was loosened allowing the seepage to develop through the seam. It was not clear if the weak seam occurred in both layers of Geocell or only in the top layer.

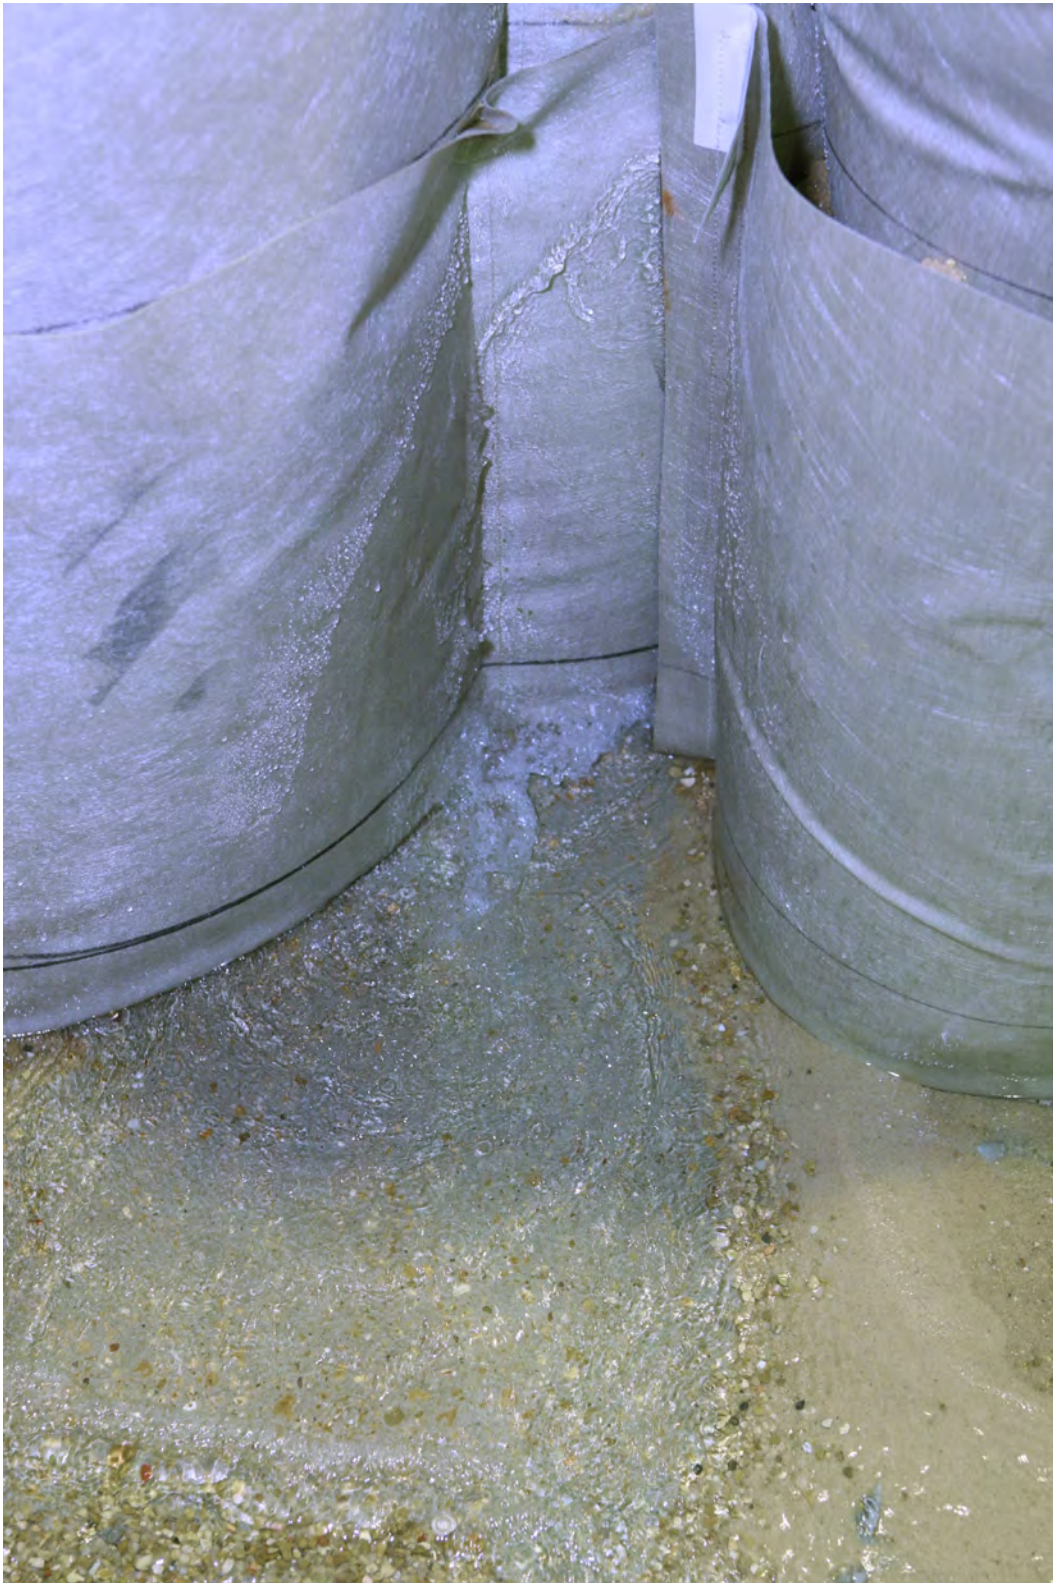
Figure 58. Close up of flow through joint in Geocell unit.

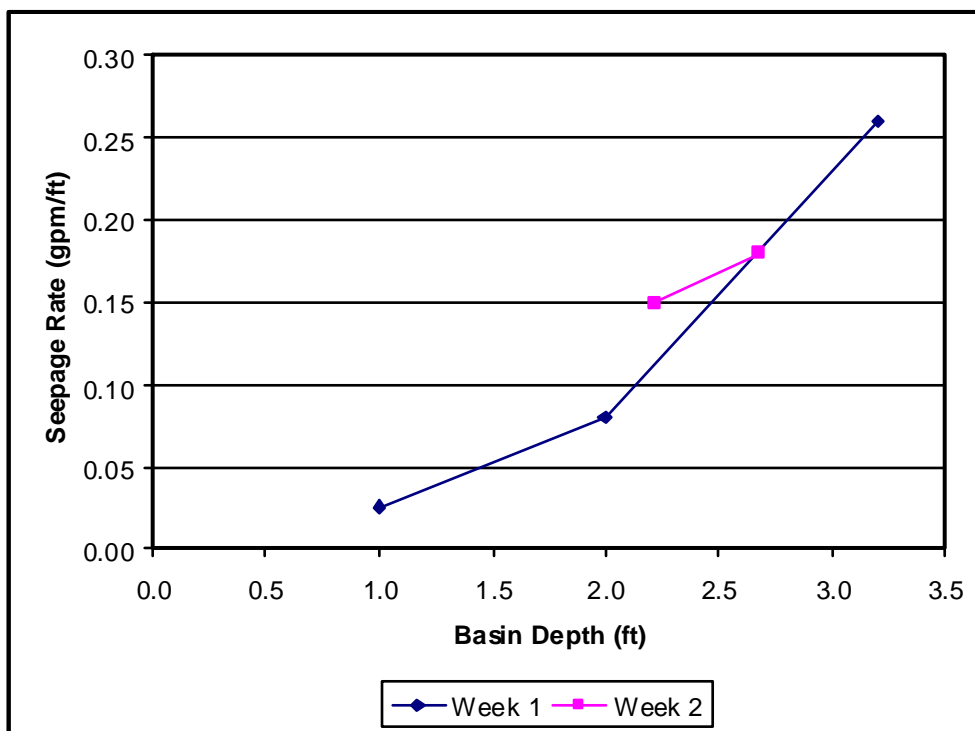
Seepage rates are shown in Figure 63 for the hydrostatic tests in week 1 of the testing (1.0 ft, 2.0 ft, and 3.17 ft depths) and in week 2 at the start of the hydrodynamic tests at low water (2.22 ft depth) and high water (2.67 ft). Seepage rates for the two weeks are consistent. On disassembly it was found that much of the seepage, at least at high water levels, was coming through one seam between adjacent Geocell units that may have been loosened during construction. At a basin depth of 2.88 ft, it appeared that one-half the seepage was coming through this one seam.

Figure 63. Summary of seepage rates. Week 1 included the hydrostatic tests. The points from Week 2 were at the start of the small waves test at low water and high water.
