BIOBARRIER®

**ROOT CONTROL**

PROJECT: Parc Soucy, Delson, QC

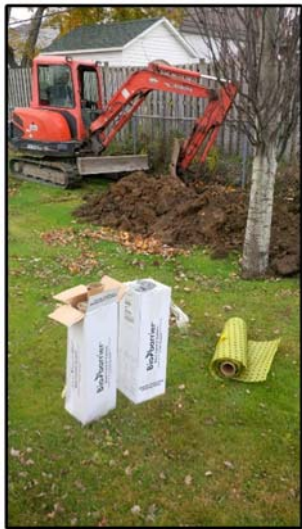
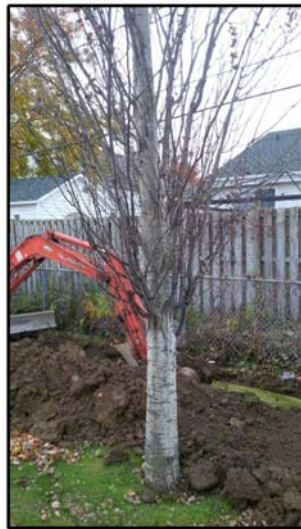
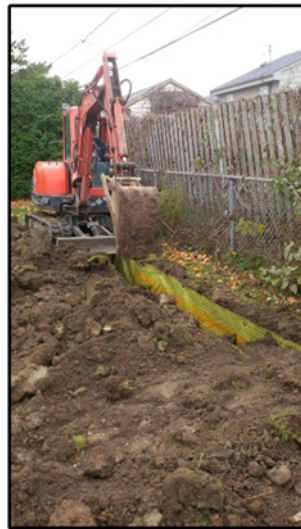
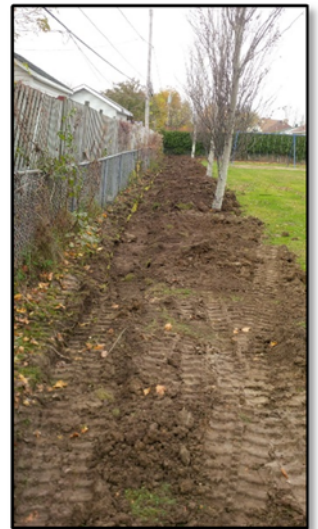
PROBLEM: Poplar trees 8” in diameter. Root system invading private properties adjacent to park.

SOLUTION: Biobarrier was placed vertically in a trench 30” deep. The trench was dug parallel to the fence the full length of the property. The trench was then backfilled and compacted.
