Tree roots can cause extensive damage to foundations (cracks, leaks), walkways and driveways (cracks, protrusions).

A homeowner had been experiencing these problems to his driveway and sidewalk due to the mature trees on his property.

They did NOT want to cut down the trees. The solution they opted for was **Biobarrier**.

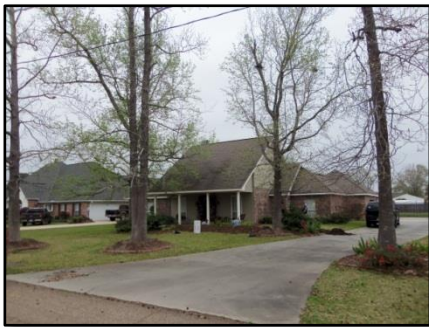
- *General view of property and driveway showing mature trees.*
- *A trench was dug to a depth of 36”.*
- *Biobarrier was positioned vertically in the trench.*
- *Plastic pegs supplied with each roll were used to secure the Biobarrier in place.*
- *Soil that was removed when digging the trench was reused to fill the trench cavity.*
