The foundation of this centennial house could not withstand the force of root intrusion. The tree roots had made their way through the foundation and some had even grown through the concrete floor in the basement of the house. The tree is located on city property, there was no question that the tree be cut down and the city would not accept any responsibilities for the damages done to the house.

For root intrusion, the only solution is **Biobarrier!**

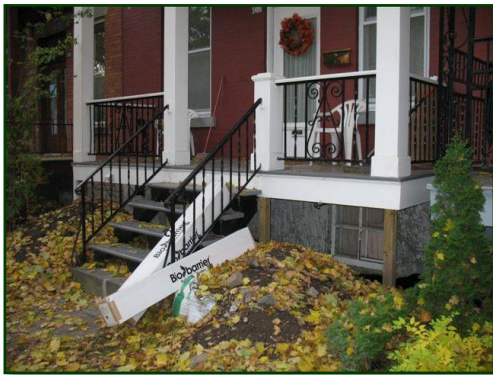
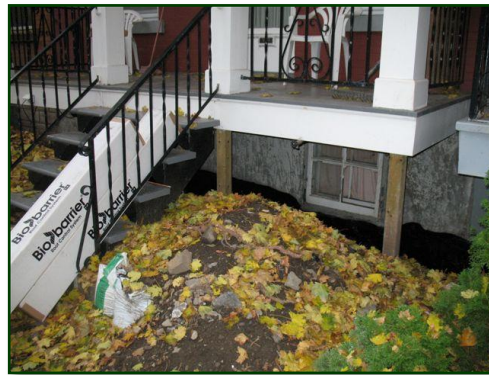
A trench was dug in the front of the centennial house.

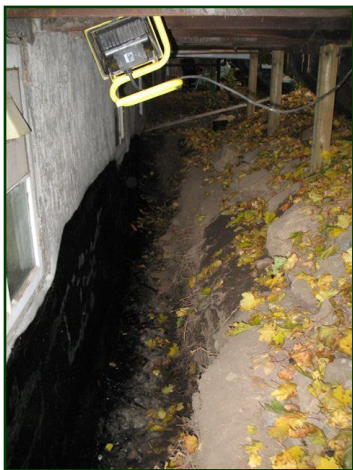
The foundation and footing were exposed.

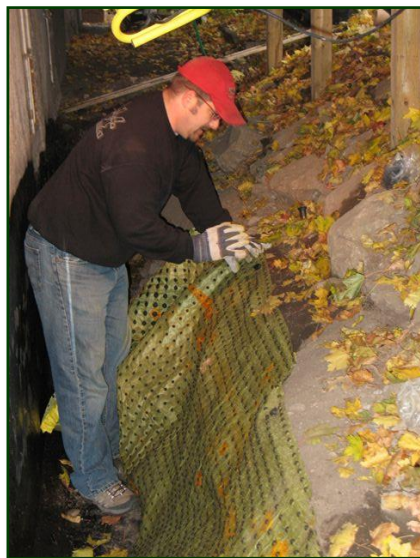
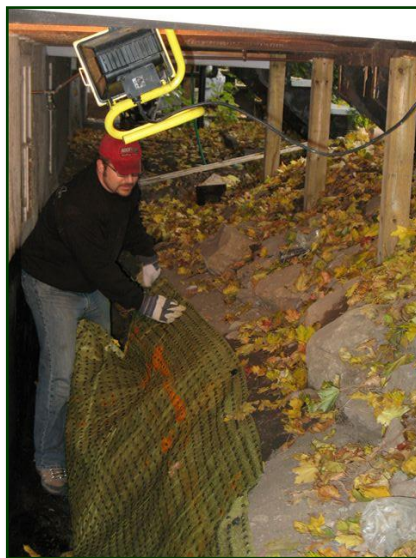
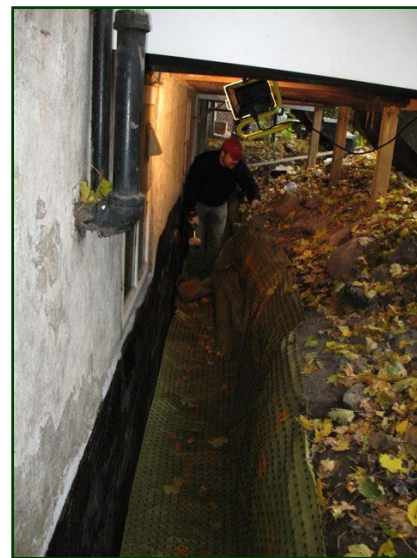
Biobarrier was positioned on the vertical slope and secured in place using plastic pegs.

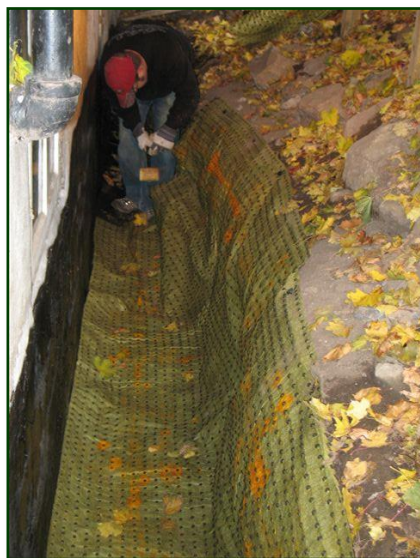
Biobarrier was also applied over the horizontal section of the footing.

For waterproofing, the foundation wall was treated with an elastomeric asphalt, extruded insulation panels were then placed over the foundation wall before filling the trench with soil.
