BIOBARRIER®

**FOUNDATION & CONCRETE  
FLOOR CRACKS**

**SAVE A HOUSE, SAVE A TREE!**

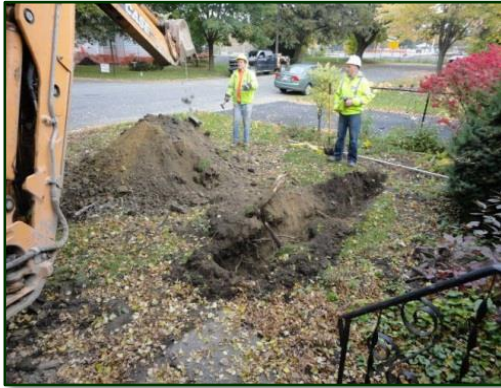
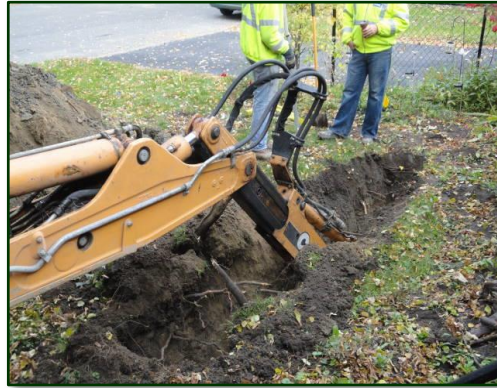
*Roots were found at a depth of 12'.*

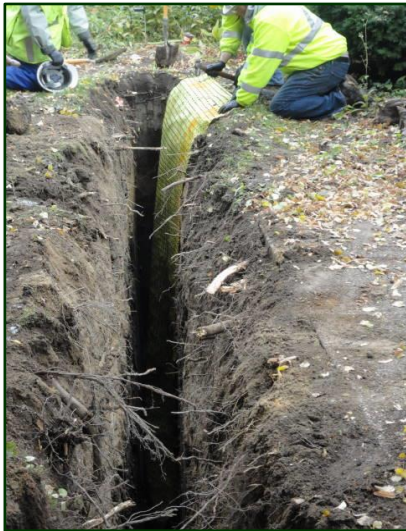
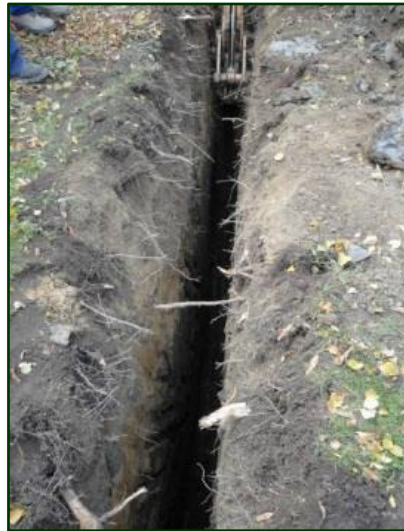
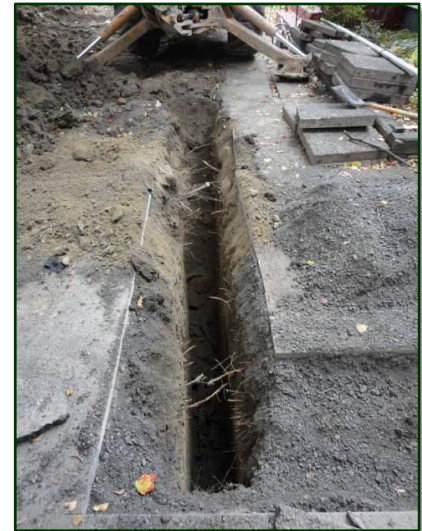
*In order to ensure that the BIOBARRIER would position itself correctly at the bottom of the 12' ditch, a wood furring for the weight was attached to one end of the BIOBARRIER.*

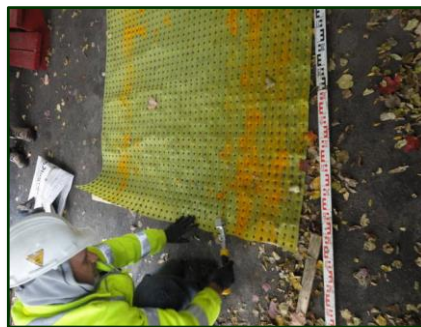
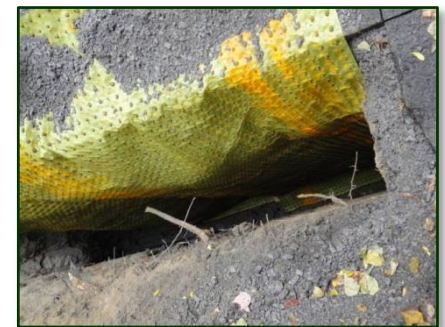
*BIOBARRIER was set vertically in the trench with a 12" section extending on the soil surface. The backfill soil was set back in place making sure that the clay would be at the bottom of the trench.*

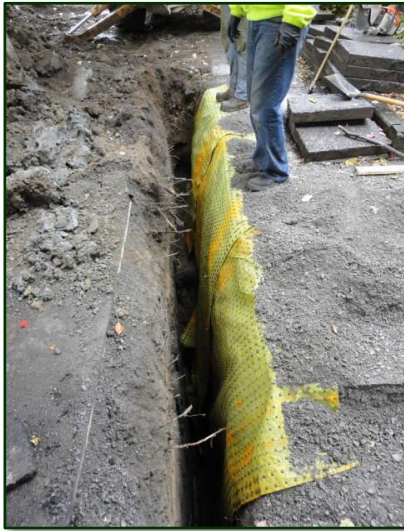
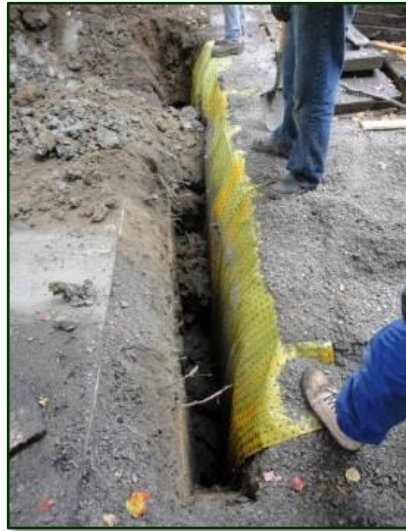
*Once the backfill was completed, the excess BIOBARRIER was folded over the trench and covered with soil.*
