TREE ROOTS INVADING A PLAYGROUND

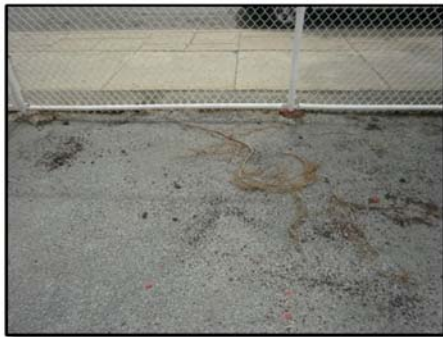
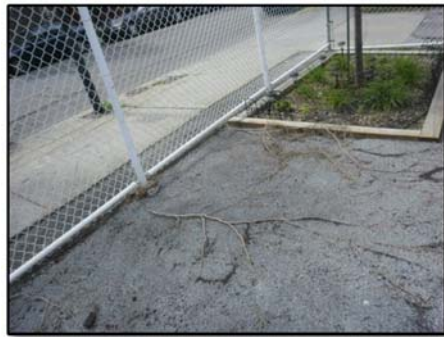
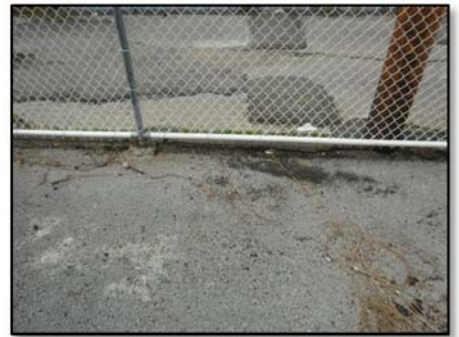
The ground surface of this playground was covered with rubber mats. Tree roots from nearby trees began invading the playground and pushing up the rubber mats.
