## **Geotextiles in Unpaved Roads: A 35-Year Case History**

### **Abstract**

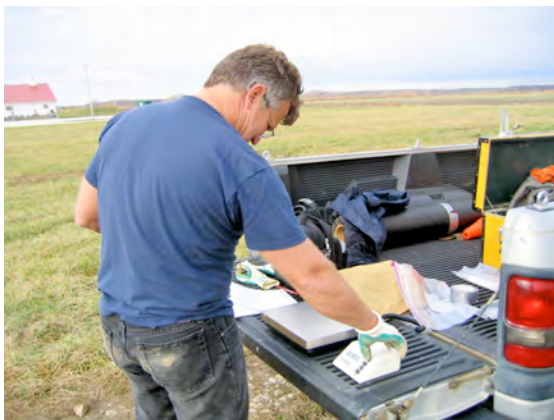
Figure 2 - Taking field measurements

Sample exhumation followed. Pick and shovel were required to break up the hard crust of the unpaved road surface, which was well compacted because the exhumation was done in the most critical area, the tire tracks. After probing for the location of the geotextile elevation, which was 4 to 8 inches (10 to 20 cm) from the ground surface, careful removal of the fill by hand proceeded over an area of approximately 1 m<sup>2</sup>. The fabric was then brushed clean. More photos were taken and the samples were removed and stored in plastic bags. Figures 2 and 3 illustrate how the geotextile samples and soil were collected, in addition to monitoring of field soil conditions.

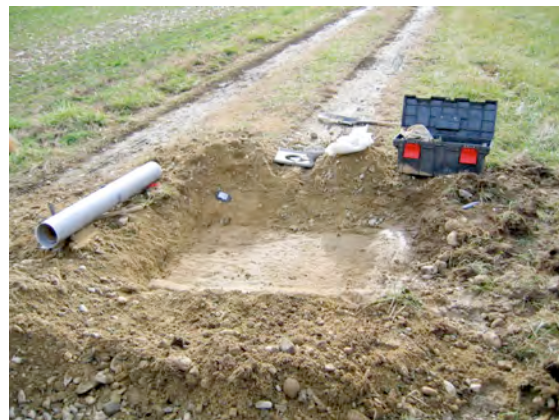
Figure 3 - Samples brushed clean

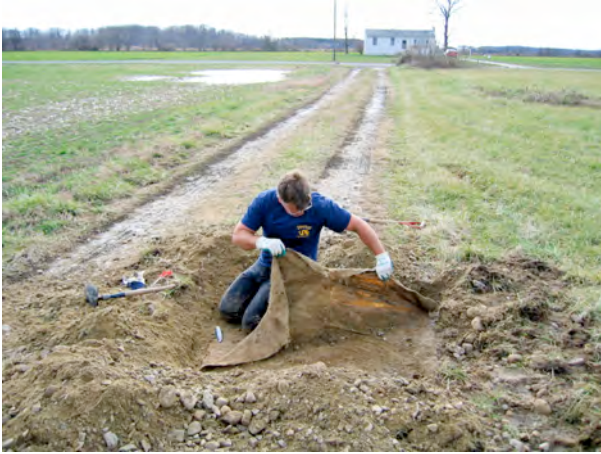
(a) GT-A

As observed from Table 4, there are 2 test sections 1 (GT-A) and 5 (GT-D) which had minimum cover (6 inches or more) and were still performing well. The others were not exhumed or in “bad condition.” Test Section 7 (GT-E) had inadequate cover (only 3 inches) and showed significant physical damage.

Figure 4 - Exhumed geotextiles at Smyrna, Delaware, site

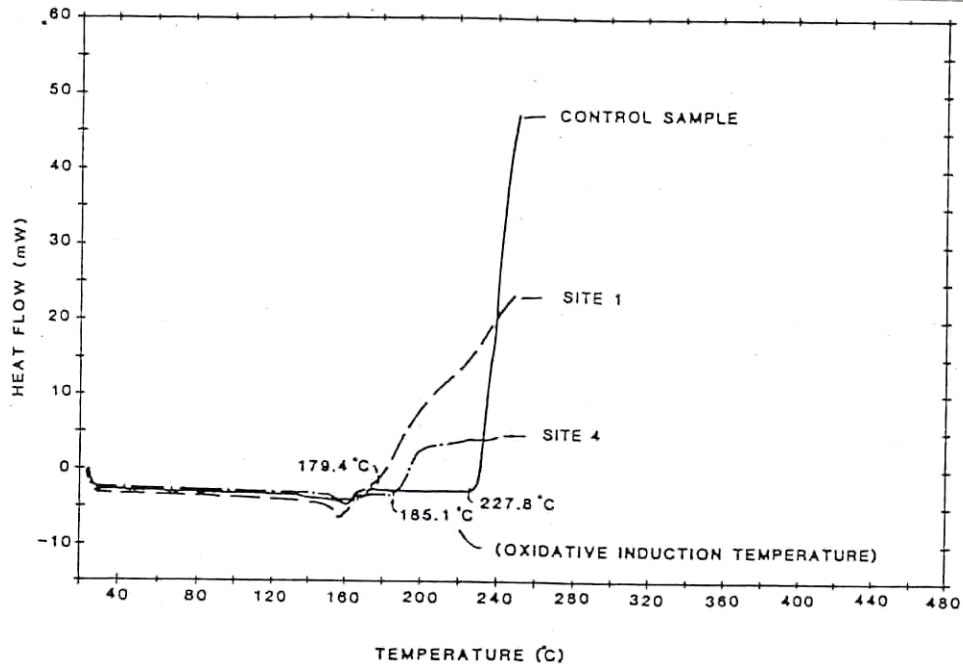
Figure 5 - Original 01 temp curve for Typar

Never the less, one of the goals of this study was to determine whether the same amounts of antioxidants and ultraviolet stabilizers are present today as when the material was produced. In pursuing this goal, it became clear that a review of the heat flow (melting) curve and a review of the thermo oxidative time and temperature as compared to the 1972 stabilizer package would be of interest.

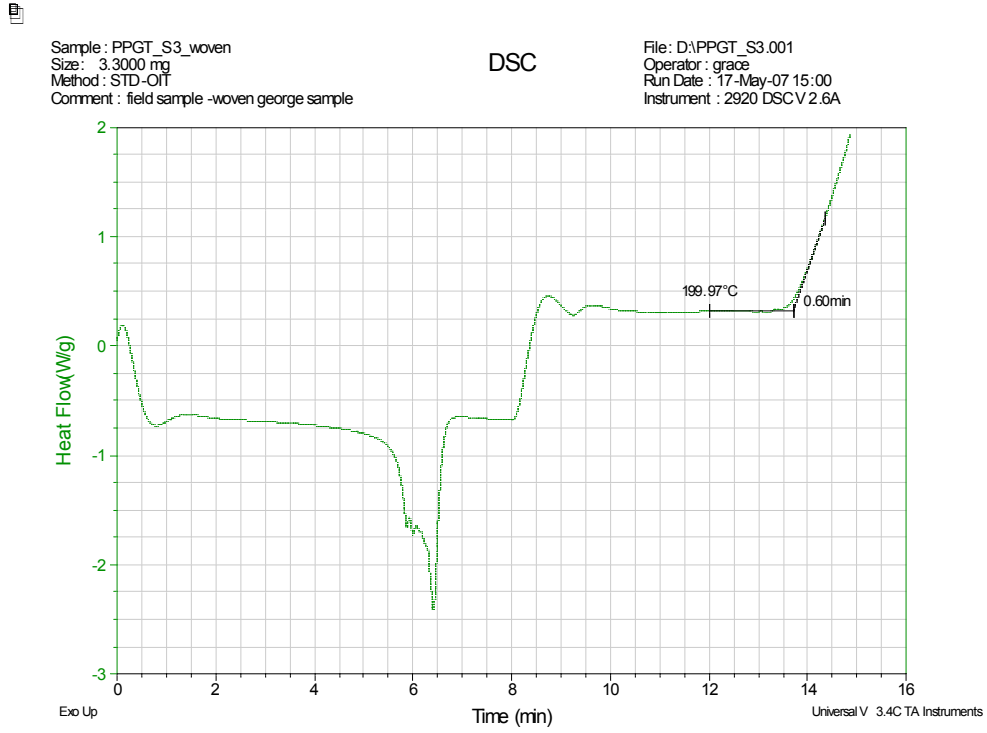
Figure 8 - Oxidative Induction Time of Field sample #3 (GT-B) a woven geotextile

oxidative induction times of GT-A and GT-B are near 1 minute. This indicates that there is a small amount of the original package currently left in these materials.
