**US Army Corps
of Engineers®**
Engineer Research and
Development Center

Evaluation of Typar® Geocell Flood Fighting Barrier

Donald L. Ward

November 2010

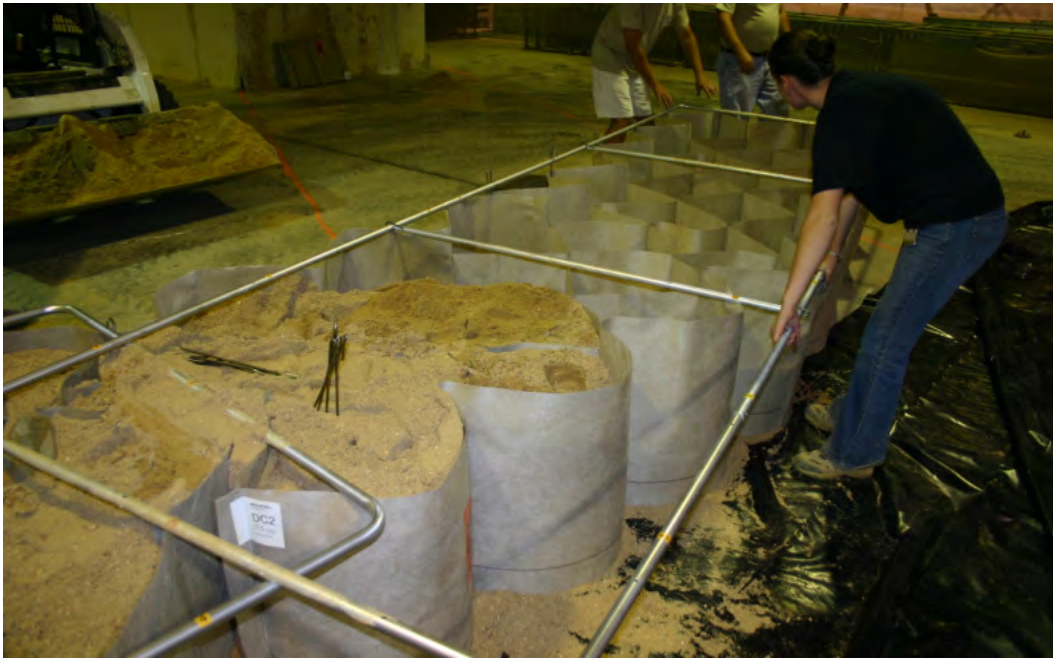
Figure 13. To fit the Geocells around a 63 deg. angle, the first cells are filled for a straight connection then the frame and remaining cells are turned to the desired angle.

The joint that included the bend in the Geocells was formed by filling the first few cells in a straight line with the previous Geocell, then turning the framework and the remainder of the Geocell to form the bend (Figure 13 and Figure 14). When the frame was rotated, the Geocell was only lightly held in place because only the first cells had been filled. It is likely that the seal with the previous Geocell was loosened allowing the seepage to develop through the seam. It was not clear if the weak seam occurred in both layers of Geocell or only in the top layer.

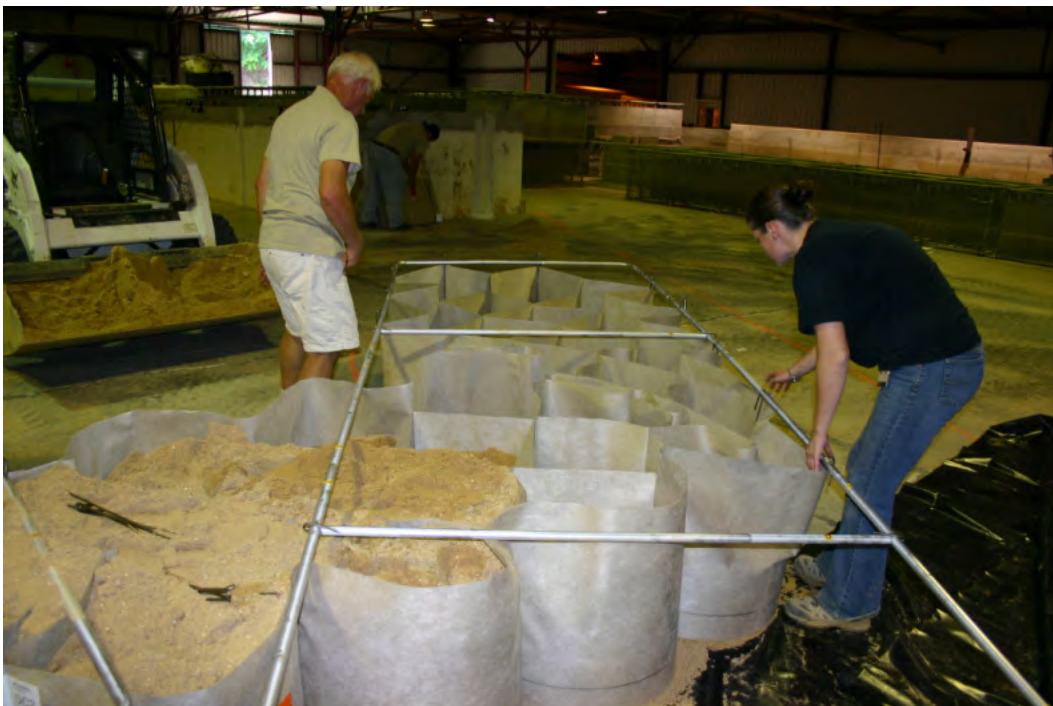
Figure 14. The frame and remaining cells have been turned to fit the designated layout.

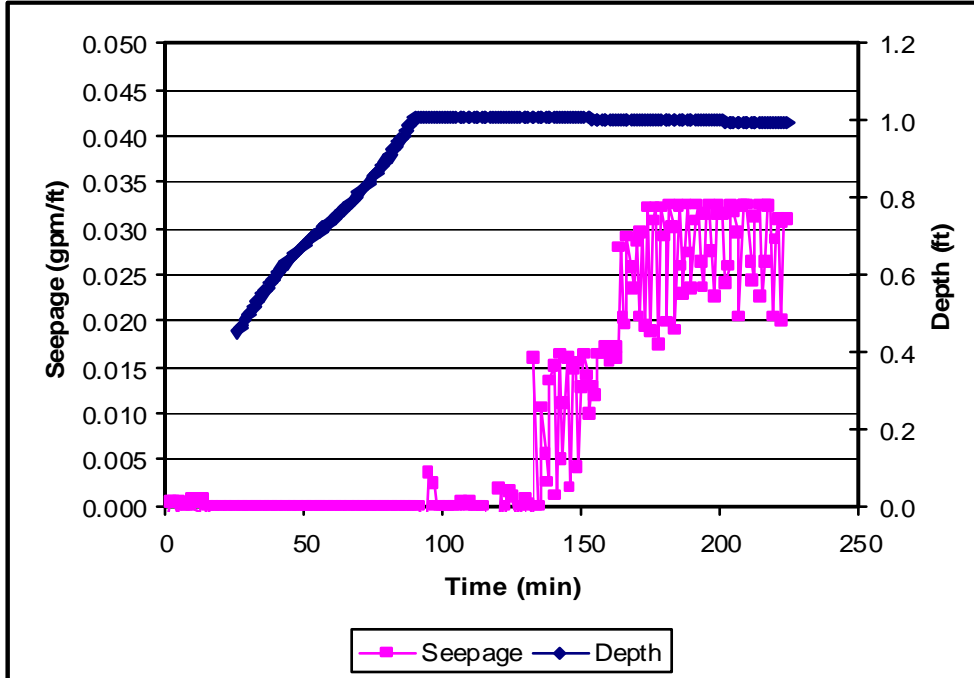
Figure 24 (starting at 1036 hrs) shows the change in measured seepage rates as the water in the test basin was brought up to the 1-ft depth. For approximately 40 min after the full depth was reached there was no measurable seepage. Seepage rate then gradually increased to an average of about 0.027 gpm/ft. Figure 25, which started at 1616 hrs, shows that the seepage rate was maintained throughout the day. The following morning (15 September, starting at 0727 hrs), Figure 26 shows a seepage rate averaging about 0.025 gpm/ft.

Figure 24. Seepage rate as water is brought up to 1 ft basin depth. Measurements started at 1036 hrs.

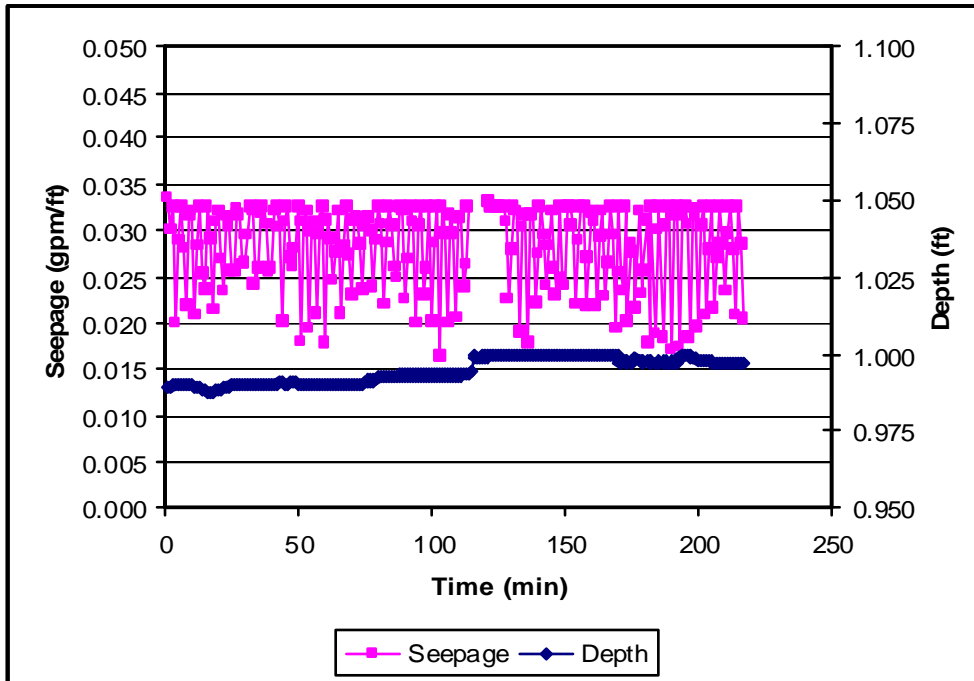
Figure 25. Seepage rate starting at 1616 hrs after 1 ft depth has been maintained for 4 hrs.

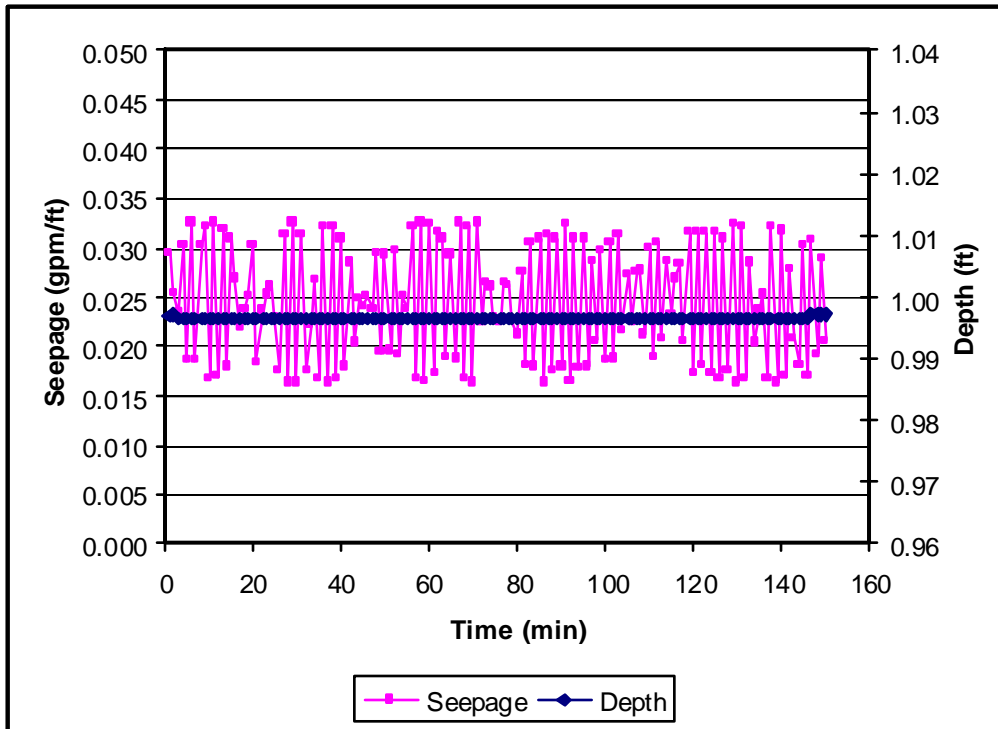
Figure 26. Seepage rate starting at 0727 hrs the following morning,

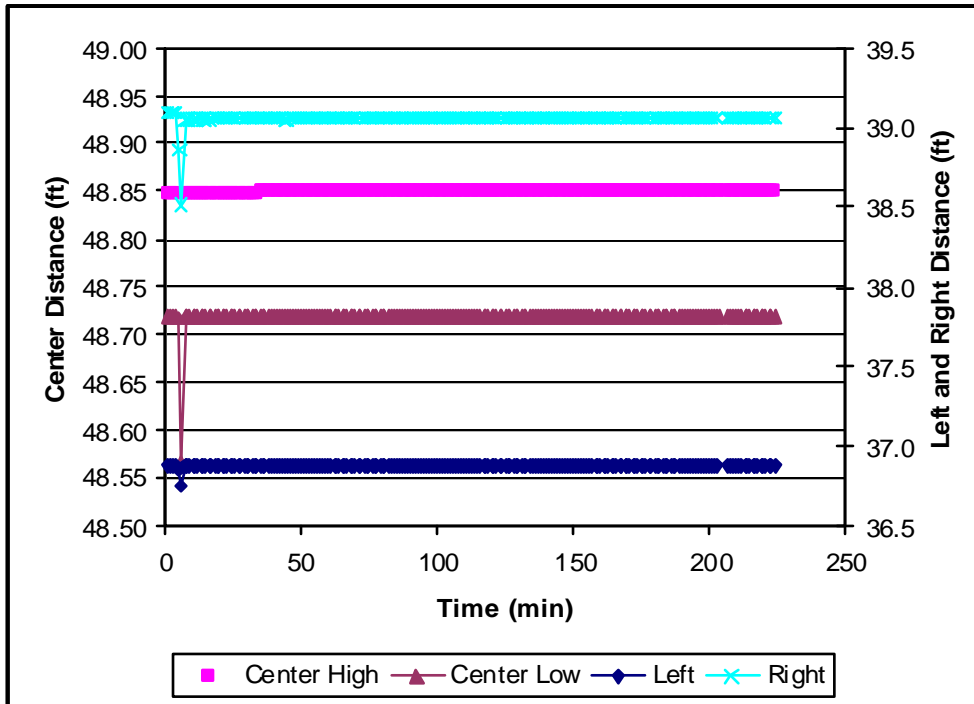
Movement of the structure during filling and settling was negligible. Figure 27 shows measurements taken during filling and one hour after filling, and Figure 28 shows measurements taken of the structure the following morning. To provide a larger scale for accuracy, the two lasers aimed at the center section of the structure are based on the primary y-axis (left-hand side) and the lasers aimed at both the left and right section of the structure are based on the secondary y-axis. Lines showing a sudden decrease in measurement (most noticeably in Figure 28) show where a person walked in front of the laser in the test area and do not represent movement of the structure.

Figure 27. Distance to structure during filling to 1 ft basin depth, measurements started at 1036 hrs.

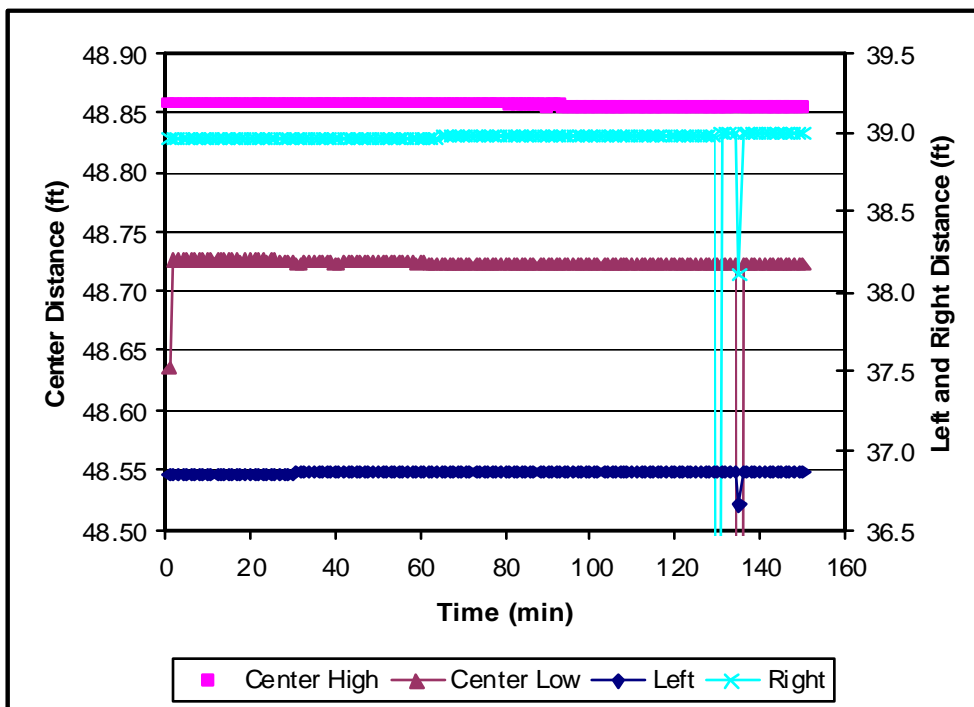
After 22 hrs at a basin depth of 1 ft, measured distances to the targets were: left target, 36.865 ft; right target, 38.988 ft; center high target, 48.854 ft; center low target, 48.723 ft. Movement of the structure was on the order of 0.01 ft towards the lasers in each case, and is probably due to settling of the fill in the cells.

Figure 28. Distance to structure starting at 0727 hrs the following morning.

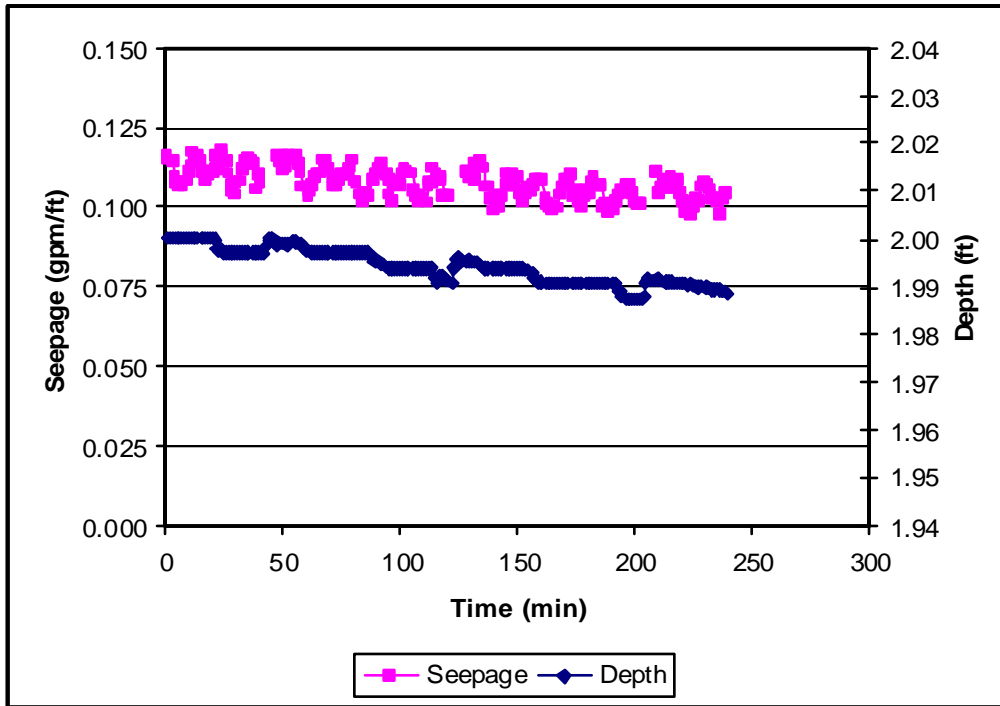
Figure 30. Seepage rates with basin water level at 2 ft. Measurements started at 1531 hrs.

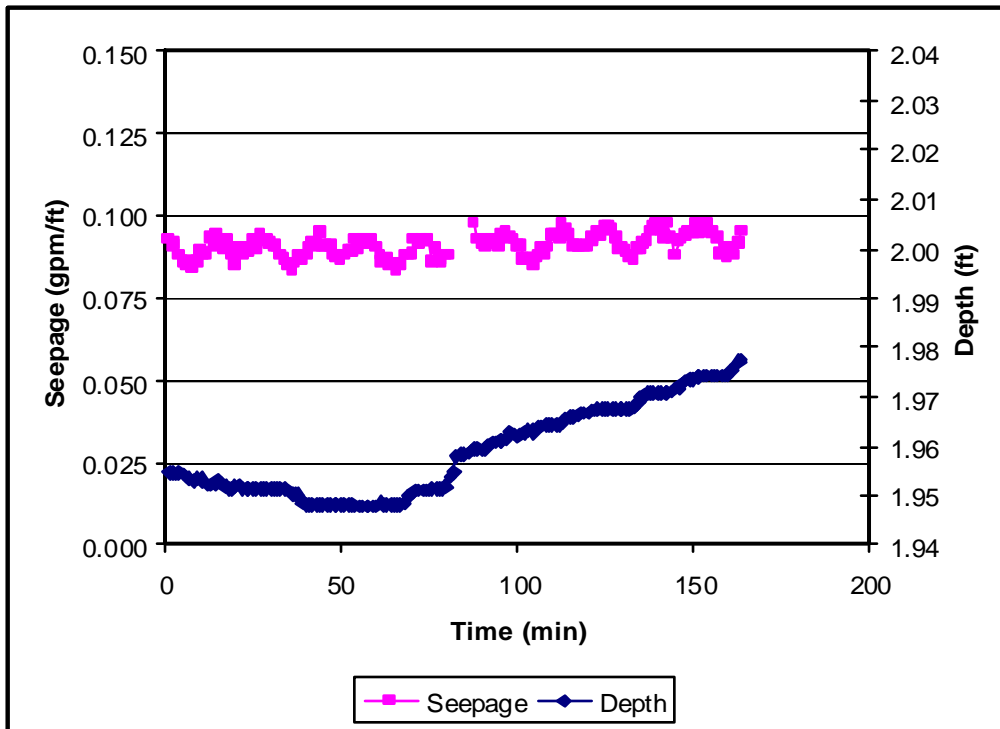
Figure 31. Seepage rate the following morning, measurements starting at 0710 hrs.

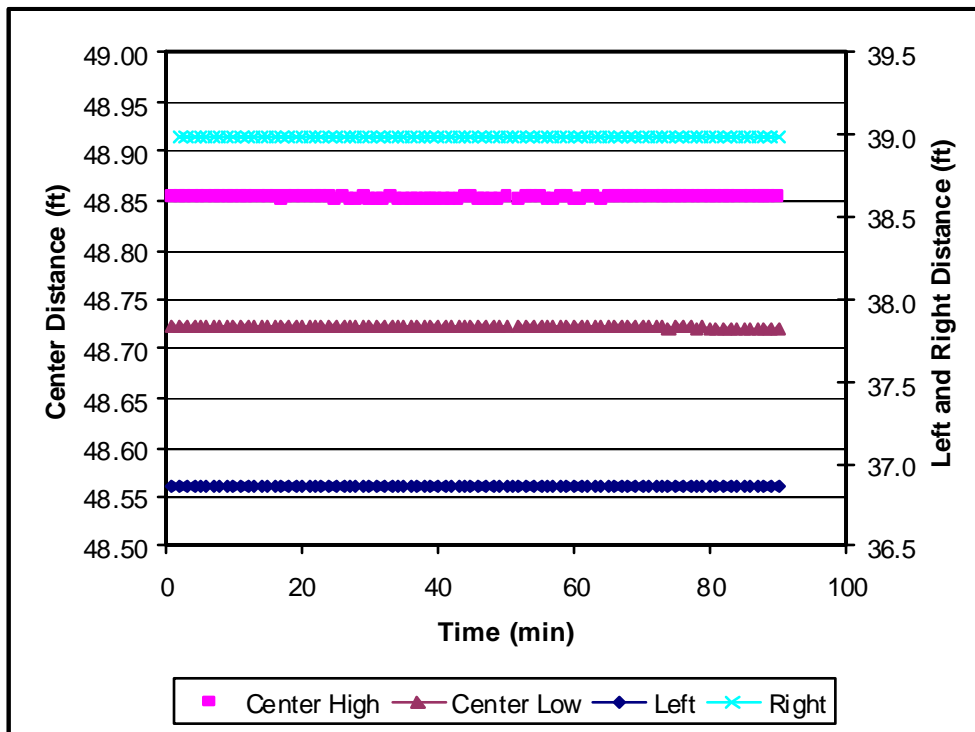
There was no discernable movement of the structure while the water was brought up to the 2 ft depth (Figure 32). At the end of the 22 hrs with water level at 2 ft, distances to the target were: left section, 36.846 ft; right section, 38.335 ft; center high and low lasers, 48.858 ft and 48.723 ft, respectively.

Figure 32. Measurements to structure walls as water level was raised to 2 ft. Measurements started at 1000 hrs.

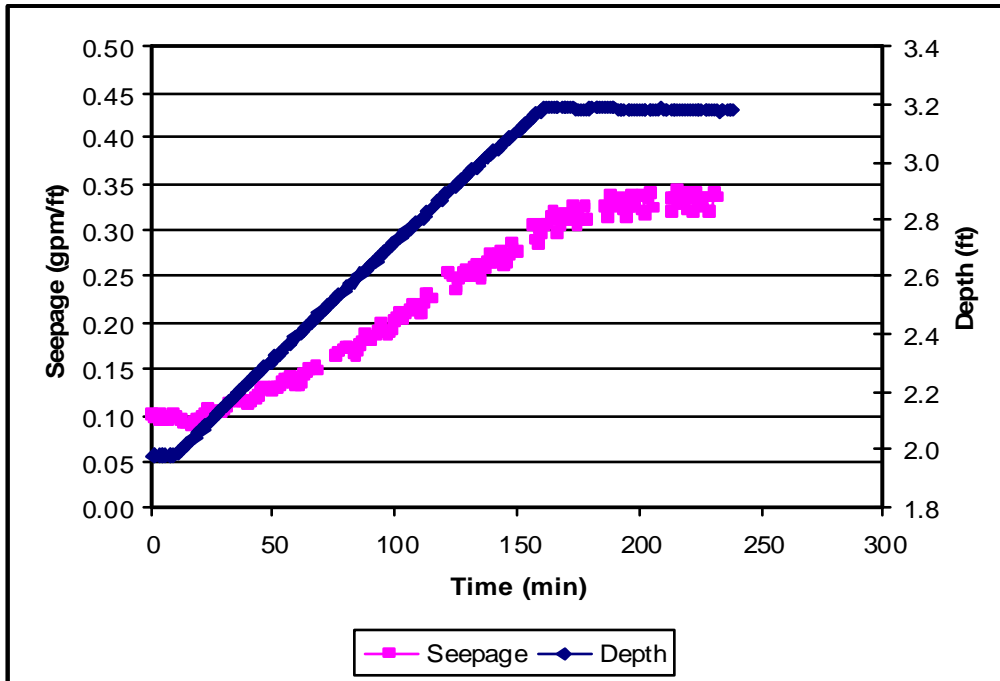
Seepage rate during filling reached a maximum of about 0.33 gpm/ft about 40 min after the depth of 3.17 ft was reached (Figure 33). Seepage rate then dropped during the afternoon to about 0.28 gpm/ft (Figure 34), leveling out at about 0.26 gpm/ft by the following morning (Figure 35).

Figure 33. Seepage rate during filling to 95% of structure height. Measurements started at 1010 hrs.

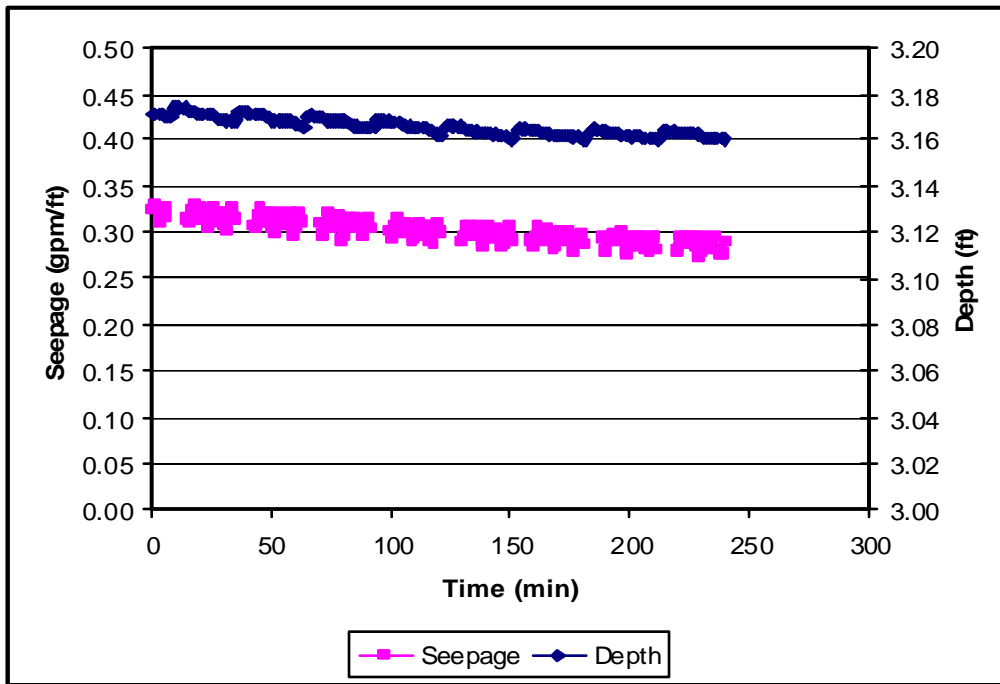
Figure 34. Seepage rates starting about 2.5 hrs after depth of 3.17 ft reached. Measurements started at 1517 hrs.

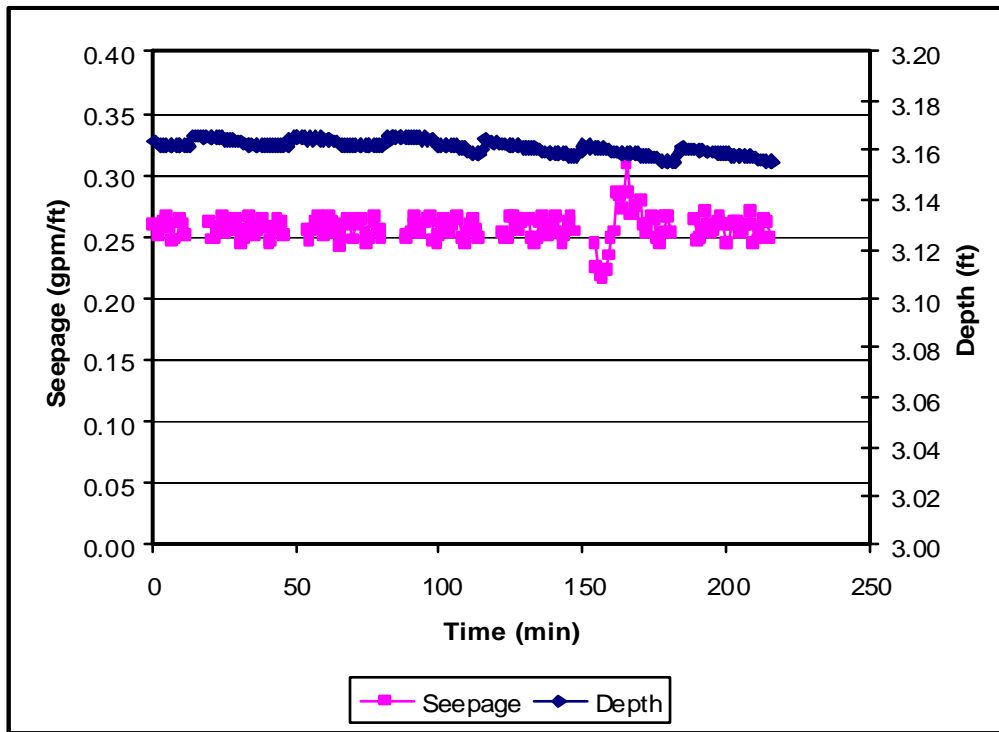
Figure 35. Seepage rate the following morning. Measurements started at 0711 hrs.

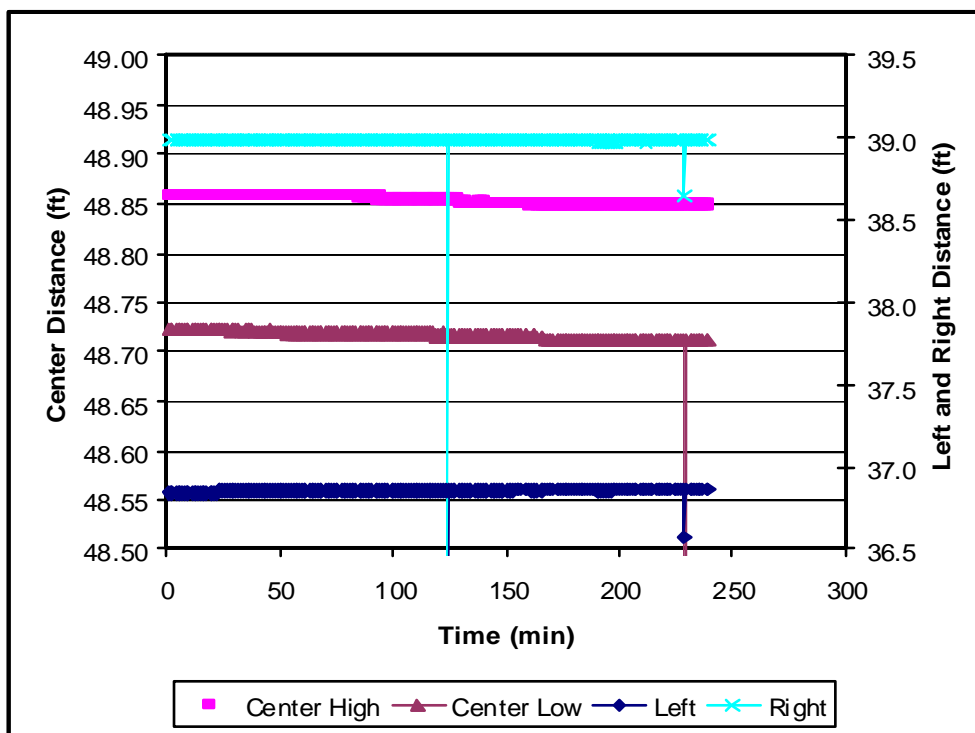
Figure 36 shows slight movement of the wall sections of the structure during filling to 95% of structure height. Four hours after starting to fill the basin, and about 1.5 hrs after maximum depth was reached, both the center high and center low targets had moved 0.010 ft closer to the lasers (approximately 1/8 in.). There was no recorded movement of the right wall section, and the left wall section had moved 0.014 ft away from the laser.

Figure 36. Structure movement during filling to depth of 3.17 ft. Measurements started at 1010 hrs.

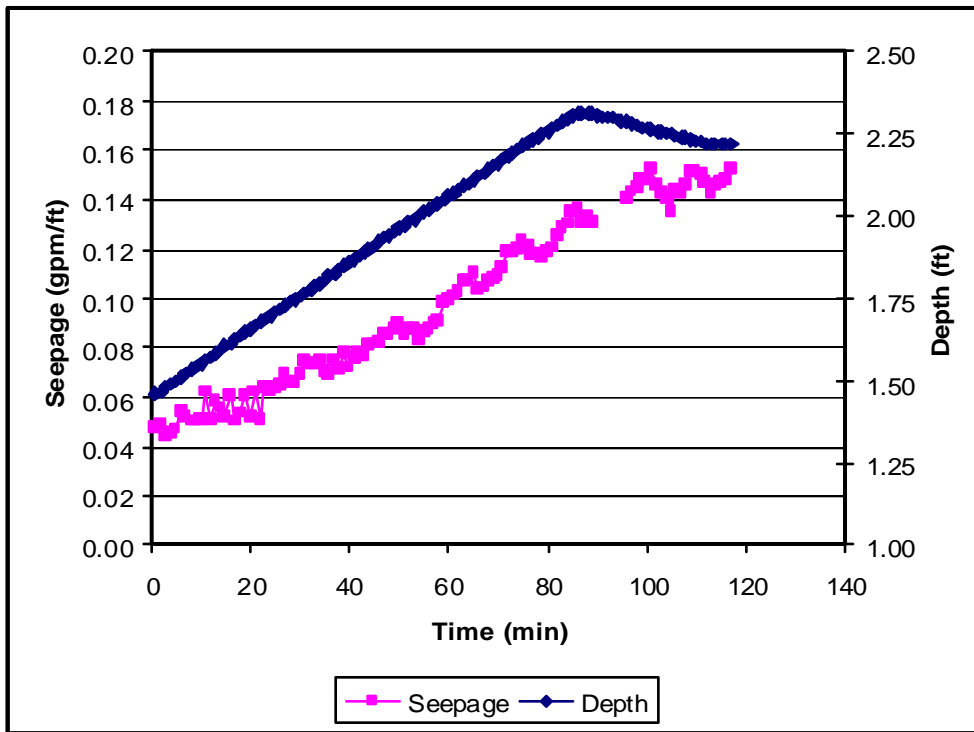
The pumps were turned on at 0825 hrs on 20 September. A depth of 67% of structure height (2.22 ft) was reached at 1205 hrs (actually the basin was over filled by about 1 in., then water level was brought back down before starting waves test). Seepage rates measured during the filling of the basin are shown in Figure 37. There was no discernable movement of the structure wall sections during filling of the basin (Figure 38).

Figure 37. Seepage rates while filling basin to depth of 2.22 ft for hydrodynamic tests. Measurements started at 1040 hrs.

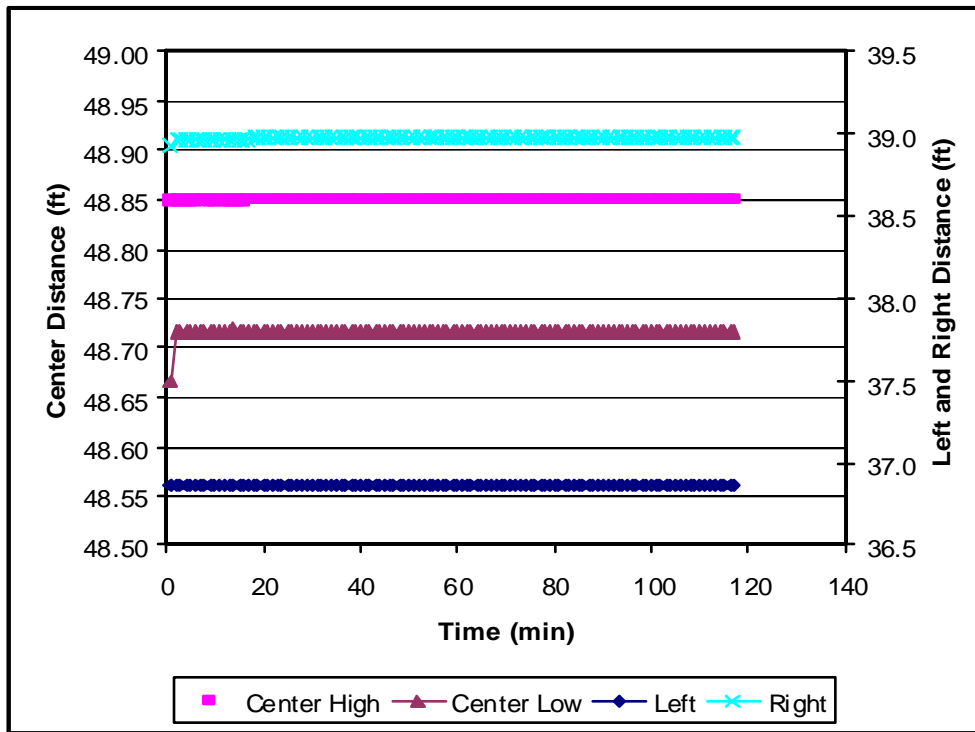
Figure 38. Movement of barrier walls during basin filling to 2.22 ft. Measurements started at 1040 hrs.

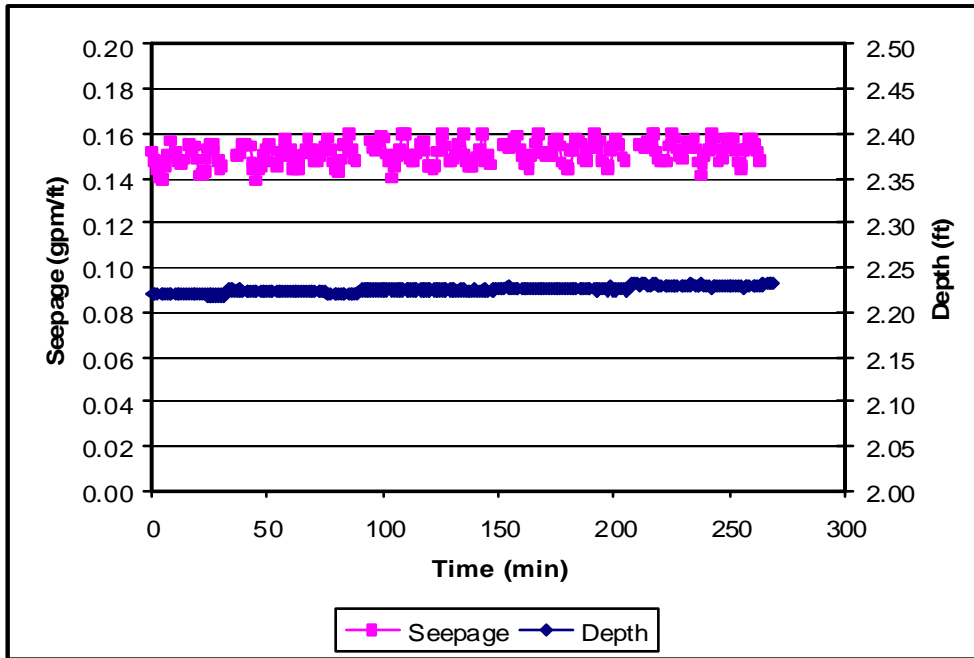
Small waves (2-in. wave height, 2-sec wave period) were started at 1234 hrs. Waves were generated for 4.5 hrs to complete the 7 hr test. Seepage rates during the test were about 0.15 gpm/ft (Figure 39). For comparison, seepage rates in the first few hours of the hydrostatic tests were about 0.11 at a depth of 2.0 ft and 0.30 at a depth of 3.2 ft.

Figure 39. Seepage rates during tests at low water, small waves. Measurements started at 1238 hrs.

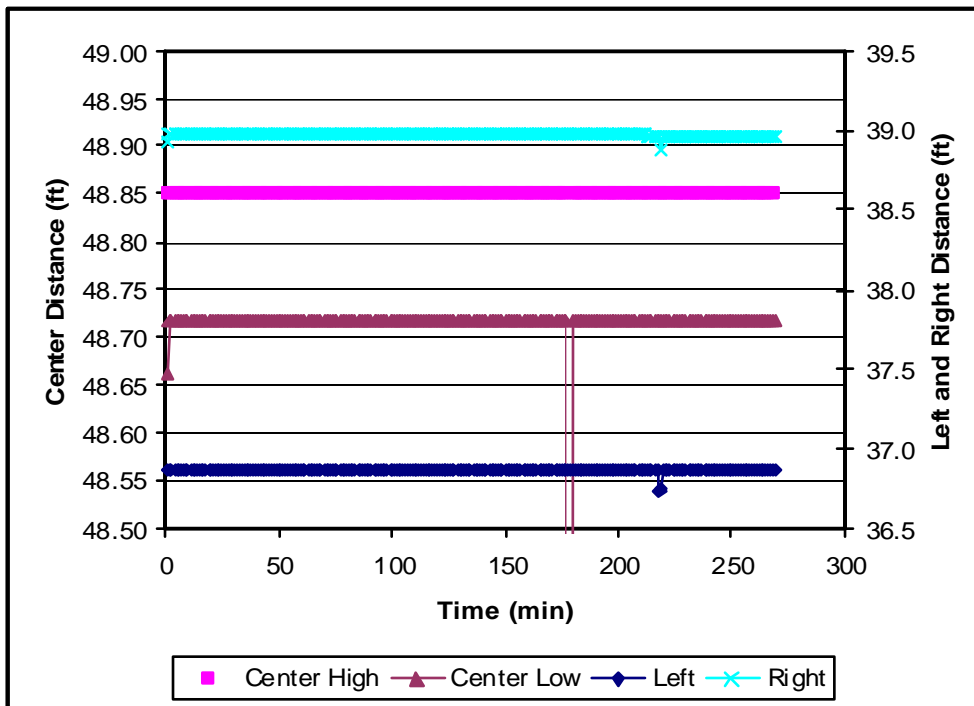
There was no discernable movement of the structure walls during the small waves test (Figure 40).

Figure 40. Measurements of wall movement during tests at low water, small waves. Measurements stated at 1238 hrs.

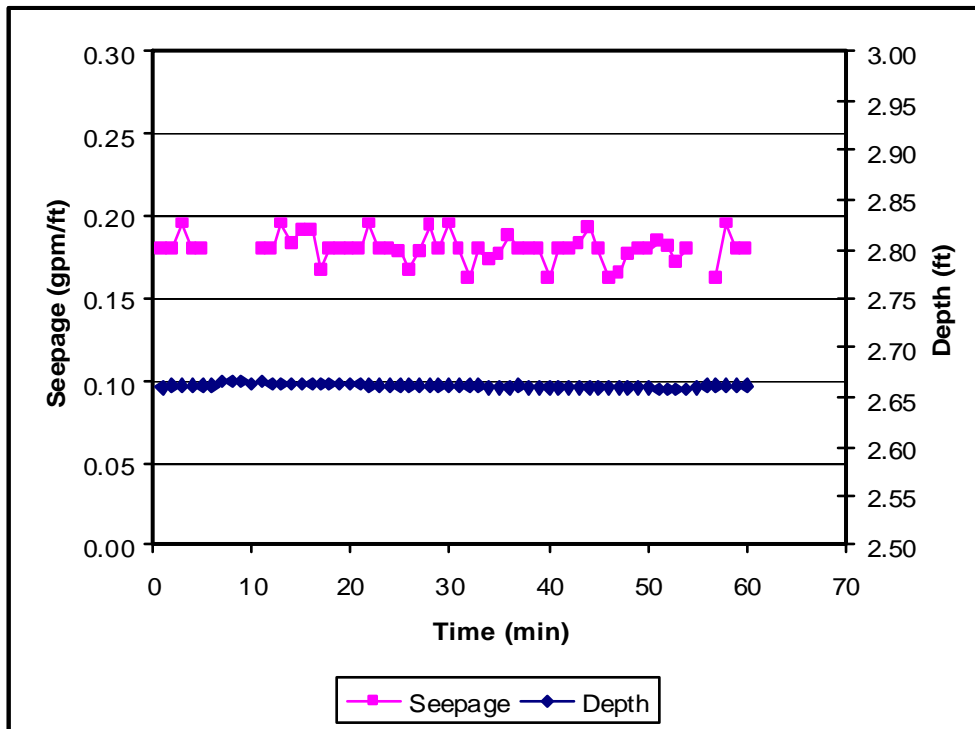
The water level in the basin was raised to a depth of 80% of structure height, or 32 in. (2.67 ft). Small waves (2-in. wave height, 2-sec wave period) were generated for 1 hr starting at 1440 hrs. Seepage rates during the test were about 0.18 gpm/ft (Figure 41).

Figure 41. Seepage rates during tests with high water and small waves. Measurements started at 1444 hrs.

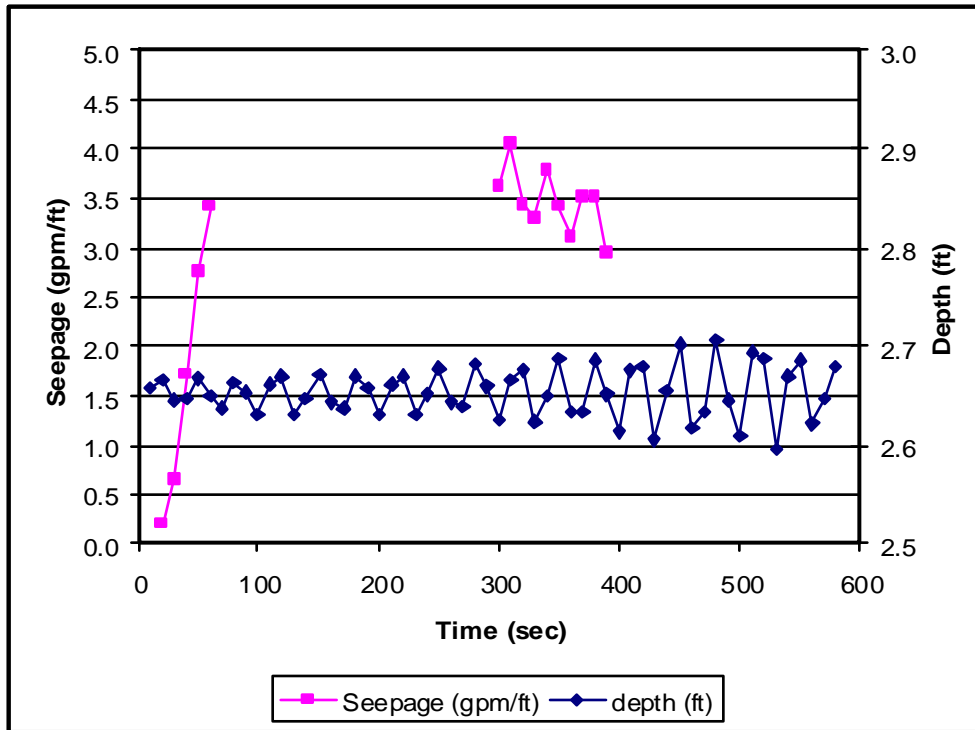
Three runs of 10-min length each were made at a depth of 80% of structure height (2.67 ft) and medium waves (6-8-in. wave height and 2-sec wave period). Waves were observed increasing in height during the run due to reflected wave energy, which is the reason runs with larger waves are limited to bursts of 10-min each. Overtopping was observed towards the left-hand end of the center section and where the structure abutted to the wing walls. Combined overtopping and seepage rate was about 3.5 gpm/ft (Figure 43). Where seepage data is missing in Figure 43 it is because the sump was being pumped down.

The water depths shown in Figure 43 should not be confused with wave action. Depth measurements were taken inside a dampening tube which will not reflect the actual motion of waves with a 2-sec period. Instead the depths shown in Figure 43 are 10-sec averages of the readings inside the dampening tube. The fluctuations in elevation are a result of the wave action, but are not to be confused with a direct recording of the waves.

Figure 43. Seepage, overtopping, and water surface elevation during second run with high water and medium waves.

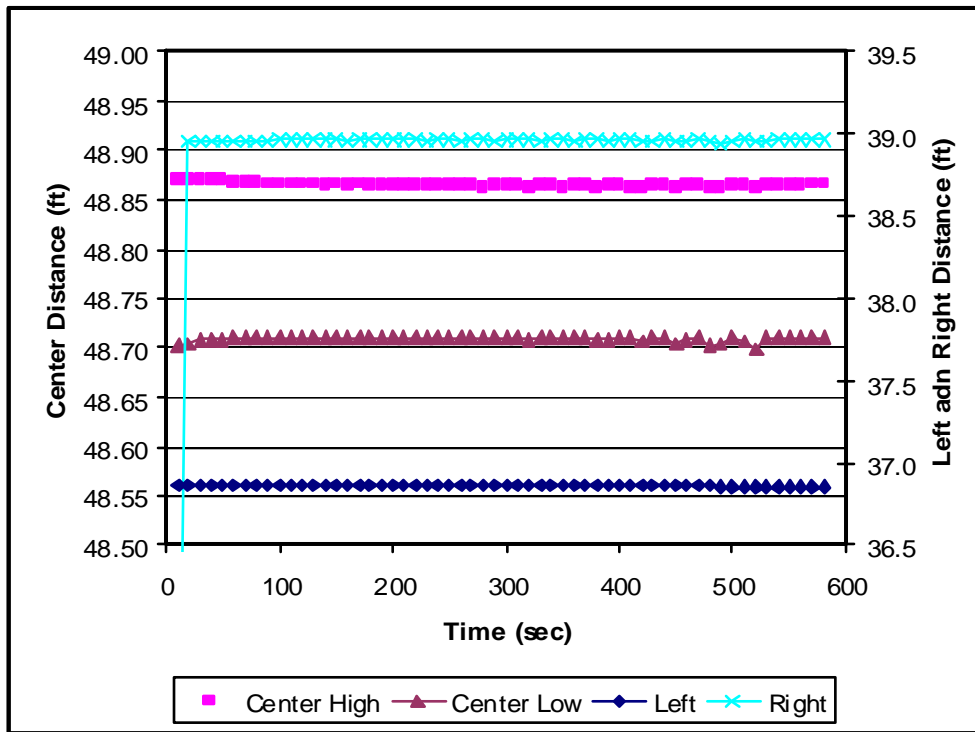
A slight movement (0.01 ft) is observed at the center high laser during the first 100 sec of the run (Figure 44). It is likely that this apparent movement is due to wave action tightening the plastic sheeting across the top of the barrier and causing the plastic sheeting inside the barrier to move slightly away from the barrier and towards the laser. Total movement is about one-eighth in.

Figure 44. Structure movement during second run with high water and medium waves.

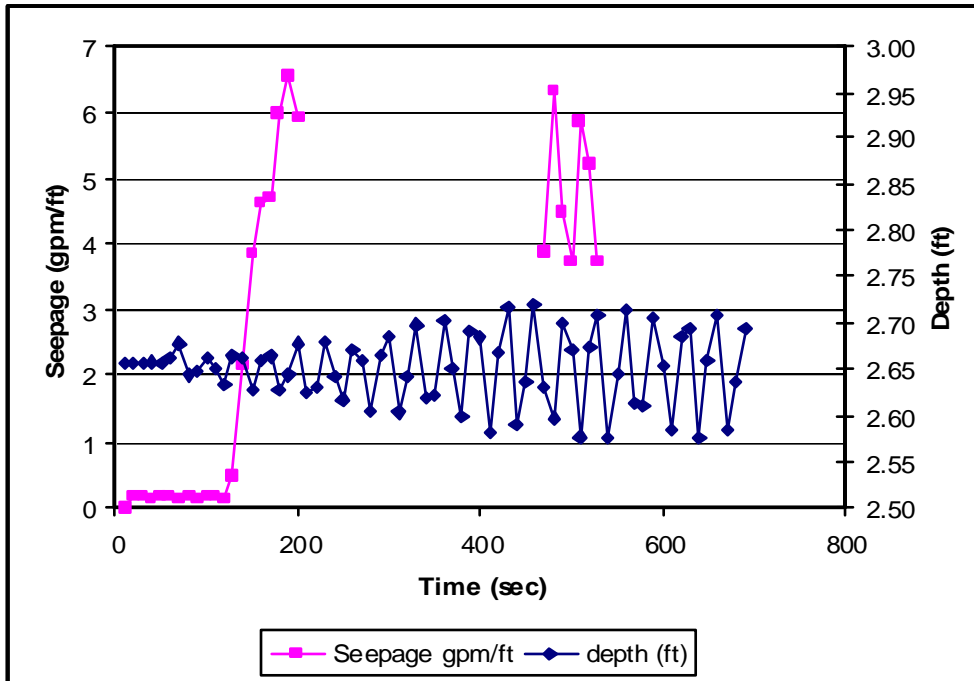
Before starting the run with high waves (10- to 12-in. wave heights and 2-sec wave period), the seepage rate was about 0.16 gpm/ft. With the overtopping from the waves, the combined seepage and overtopping was about 5 gpm/ft (Figure 45). The increase in fluctuations in water surface elevation due to the waves is evident in Figure 45, but again the fluctuations shown are 10-sec averages of depths taken inside a dampening tube and are not direct representation of wave action.

Figure 45. Seepage plus overtopping, and water surface elevation during tests with high water and large waves.

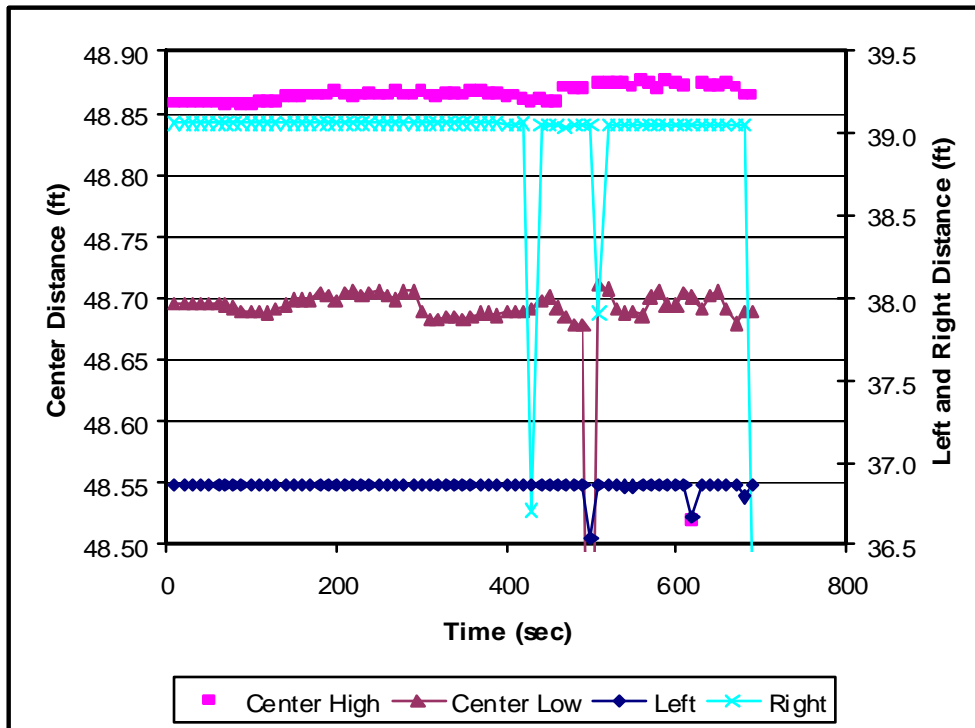
The apparent movement of the structure seen in Figure 46 is most likely due to laser reflections off the overtopping water. The laser data is collected at about 30 Hz, but the plot shows the data reduced to 10-sec averages in order to keep the file sizes manageable. As a wave overtops the structure, the overtopping water flows down in front of the target taped to the plastic sheeting surrounding the structure (Figure 47). The lasers reflect off the water surface instead of the target, causing false indications of structure movement. No actual movement of the structure was observed.

Figure 46. Structure movement during test with high water and large waves.

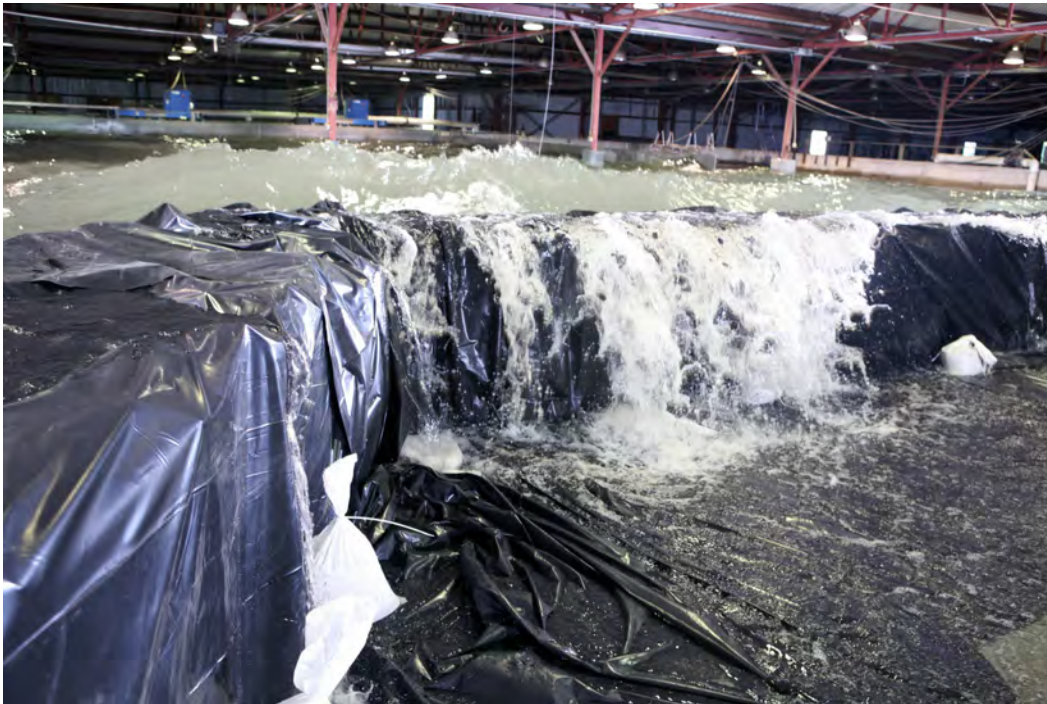
Figure 47. Wave overtopping during test with high water, large waves.

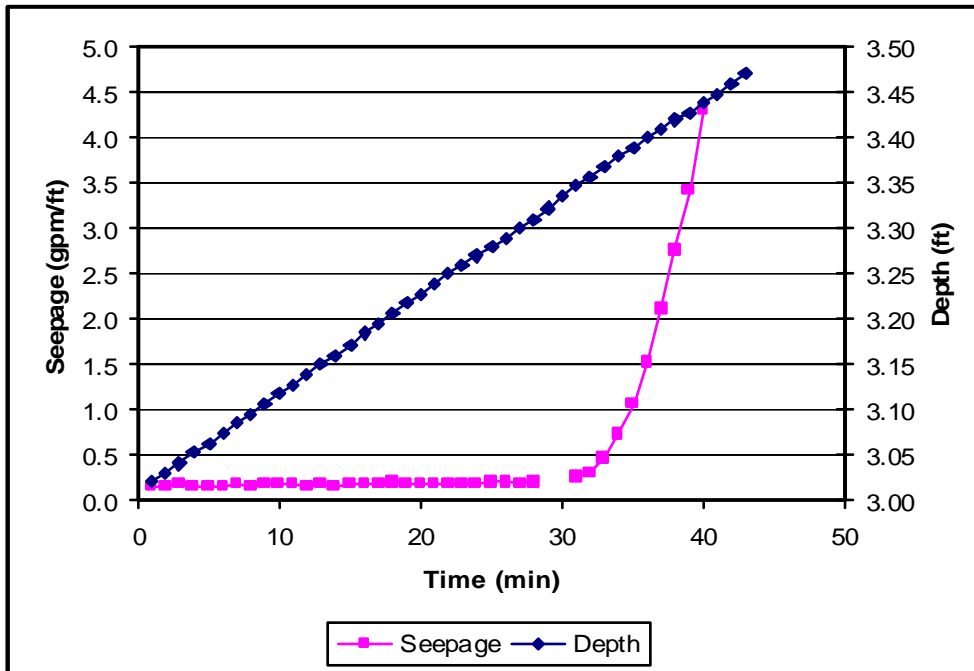
Figure 48. Water level and seepage rate as water is brought up for overtopping test. Measurement started at 0850 hrs.

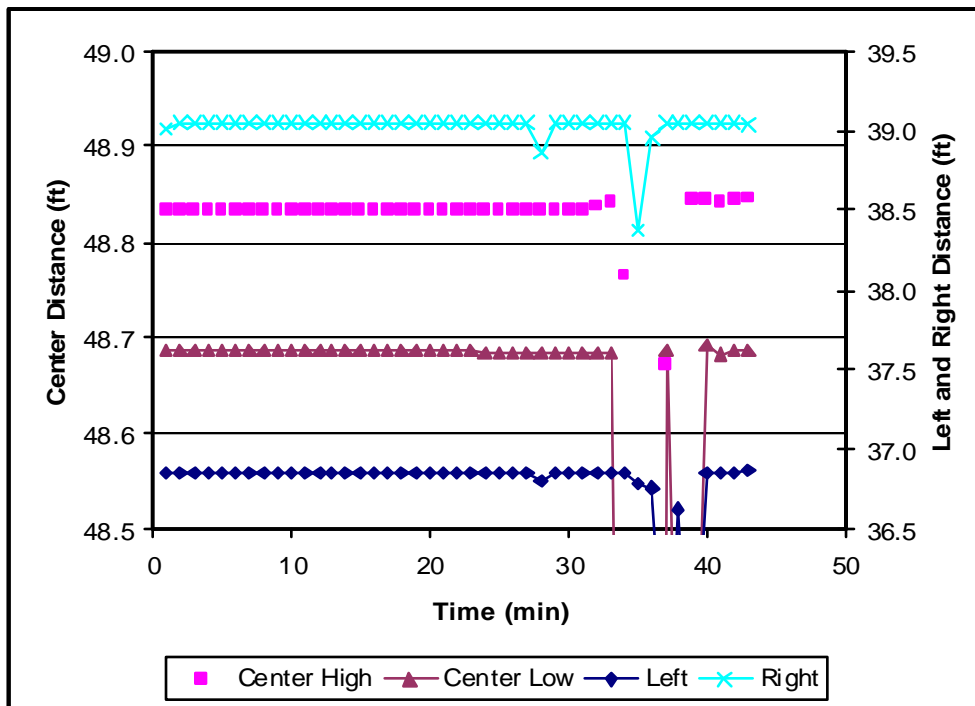
No movement or damage to the structure was observed during the test.

Figure 49. Structure movement as water level is increased for overtopping test. Measurements started at 0850 hrs.

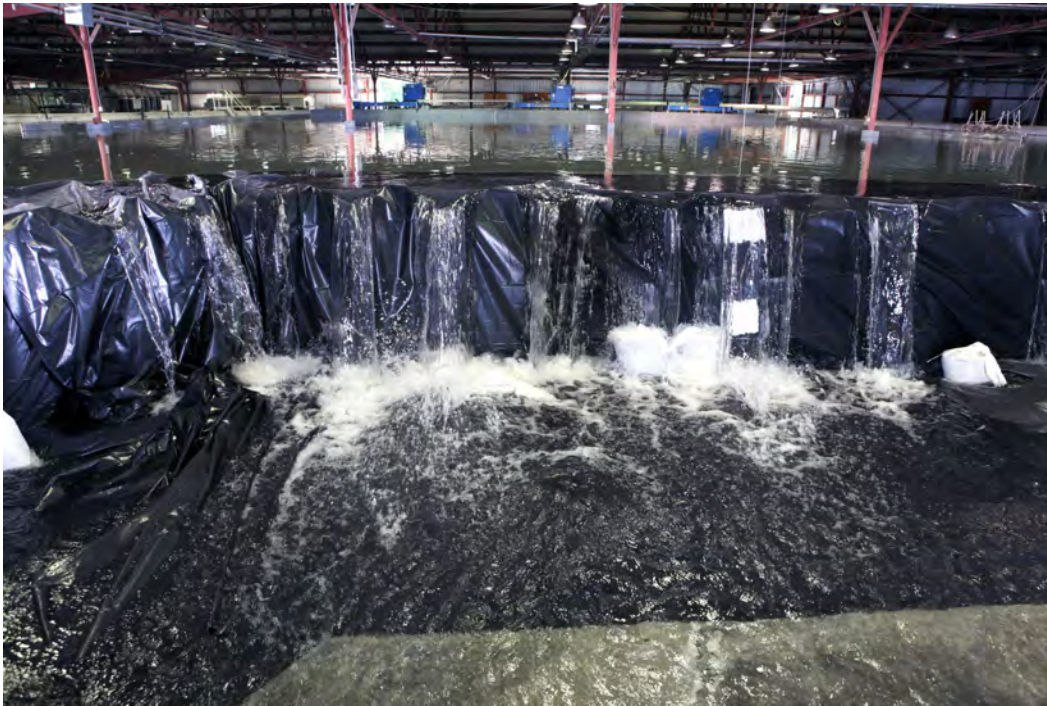
The water level was dropped to a depth of 42.2 in. for the duration of the test. Depths of flow over the structure ranged from 1 in. to 3.5 in., except for about one-half of the right section which was dry. Overtopping during this time period is shown in Figure 50.

Figure 50. Flow over the barrier during the overtopping test.

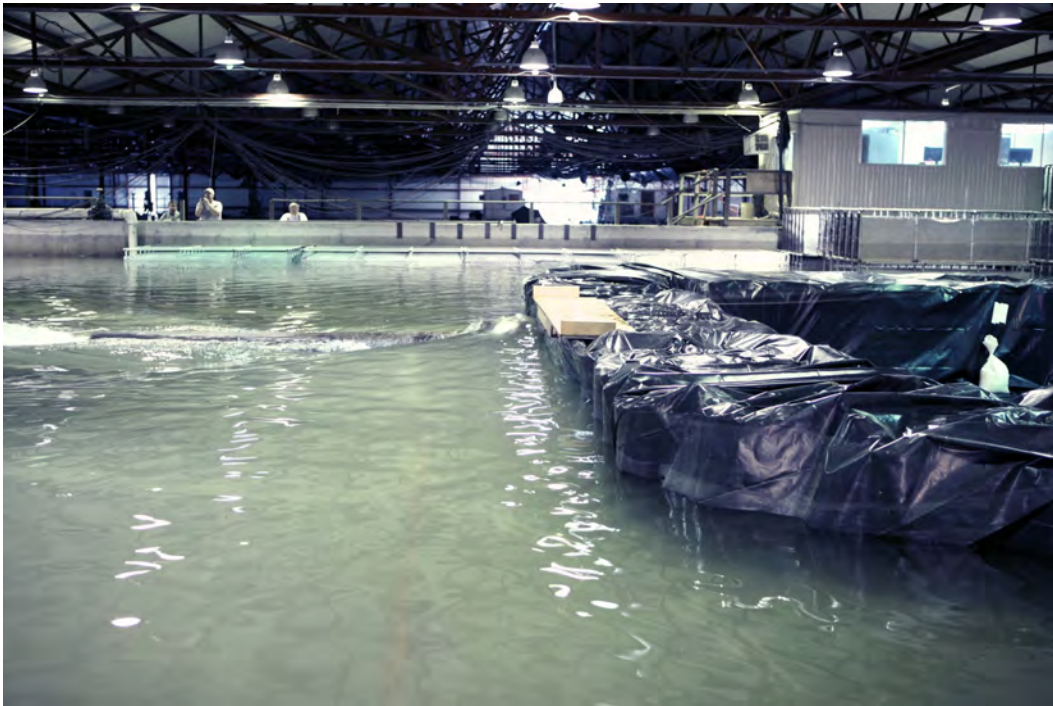
The two logs were towed into the structure one at a time, the smaller log first (Figure 53 and Figure 54). Neither log caused any noticeable damage to the structure, not even a tear in the plastic sheeting. When the plastic sheeting was removed during disassembly at the end of test series, the Geocell fabric was searched for any signs of damage from the logs. No damage was found.

Figure 53. Debris impact test with log towed into the barrier.
