**US Army Corps
of Engineers®**
Engineer Research and
Development Center

Evaluation of Typar® Geocell Flood Fighting Barrier

Donald L. Ward

November 2010

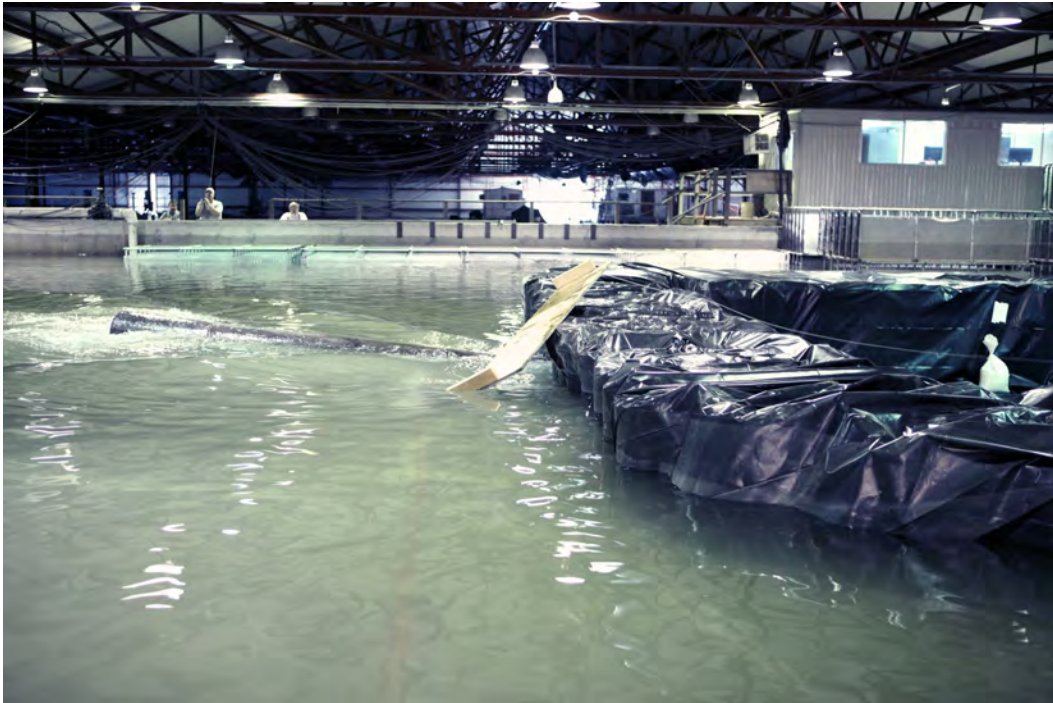
The two logs were towed into the structure one at a time, the smaller log first (Figure 53 and Figure 54). Neither log caused any noticeable damage to the structure, not even a tear in the plastic sheeting. When the plastic sheeting was removed during disassembly at the end of test series, the Geocell fabric was searched for any signs of damage from the logs. No damage was found.

Figure 54. Debris impact test as log struck barrier.

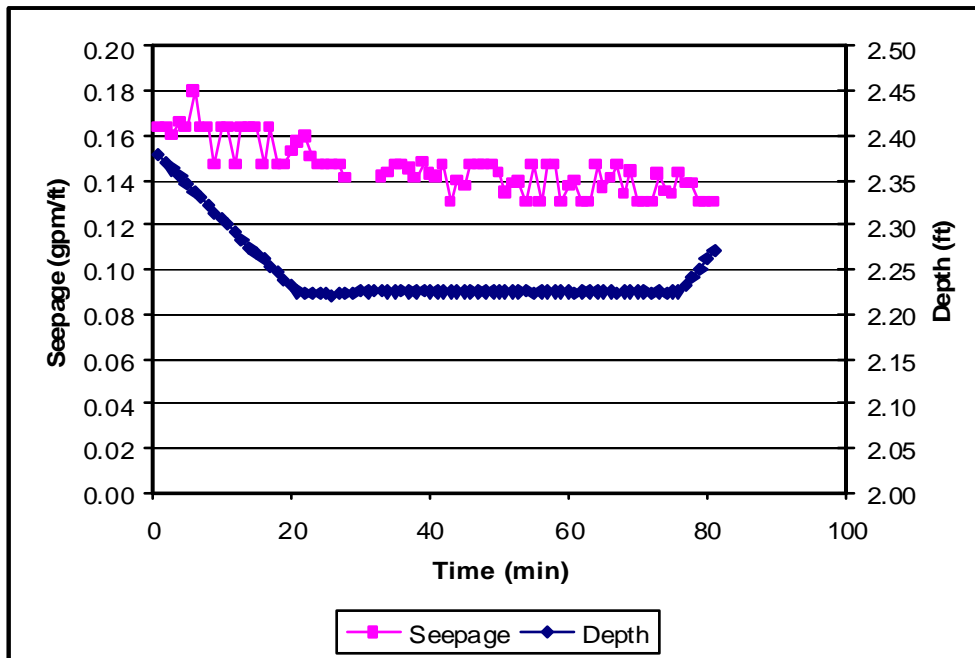
The debris impact test was conducted at a water depth of 66.7% of structure height, or 2.2 ft. Seepage rates recorded as the water depth was lowered to the test level and held throughout the test are shown in Figure 55.

Figure 55. Seepage rates during debris impact test.

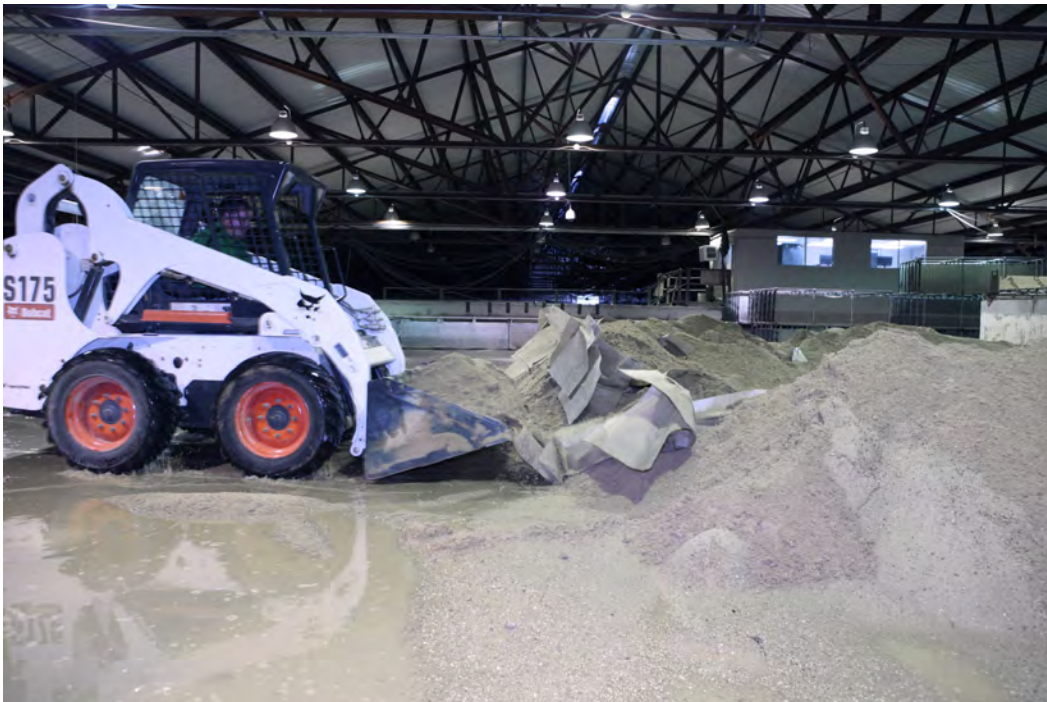
While the top layer of Geocells lifted easily out of the sand, the Bobcat™ operator had more trouble with the lower layer. Many of the Geocells ripped when being lifted by the forks. Because the Geocells were not intended for re-use, tearing the cells was only an issue in that it made removal more difficult. The forks on the Bobcat™ were therefore swapped for the front bucket. Because the outer walls of the cells had been cut, much of the sand could be removed with the front-end loader (Figure 62). After removing the outer areas of sand, the center section was picked up with the bucket, picking up both sand and fabric. By careful dumping, the sand was dumped into the pile while the fabric either remained with the bucket or was easily removed from the sand pile by hand.

Figure 62. Sand is removed with front-end loader from each side of the barrier.
