Vinegar Tree Roots Damaging Pool Liners

Many residents of the municipality of Delson (Quebec) were complaining about the intrusion of roots from Vinegar trees surrounding their property. At one point, the roots were perforating swimming pool liners.

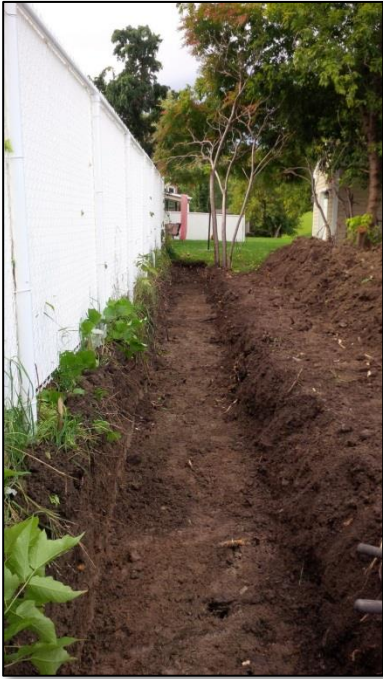
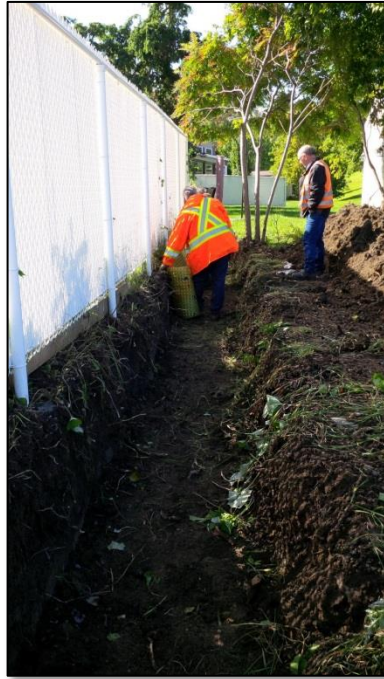
Plastic pegs supplied with each roll were used to secure the Biobarrier in place.

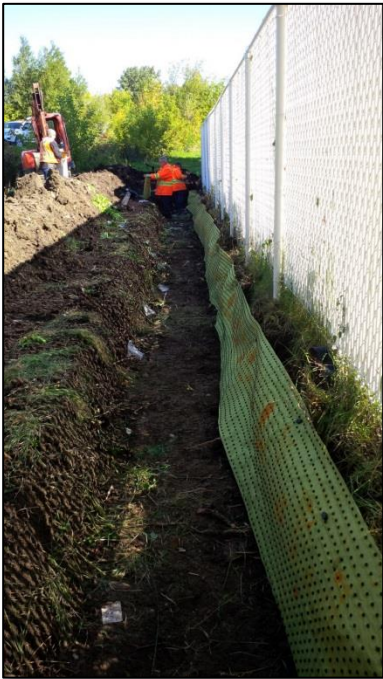
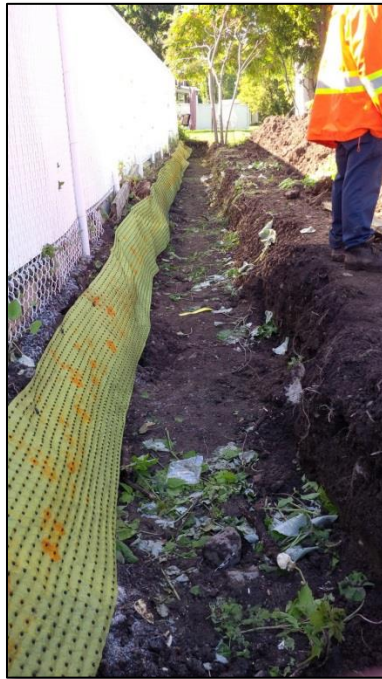
Backfilling and compacting was done.
